Mock Inspection Report

5037 Chicago Avenue, Fair Oaks, CA, USA

Jul 2, 2025

Performed by **David Erler**

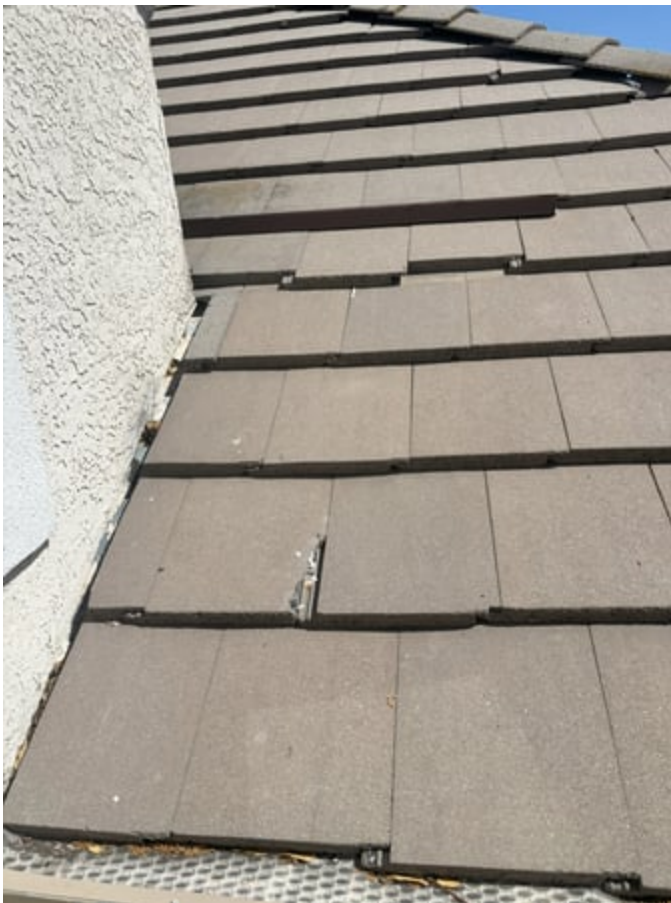
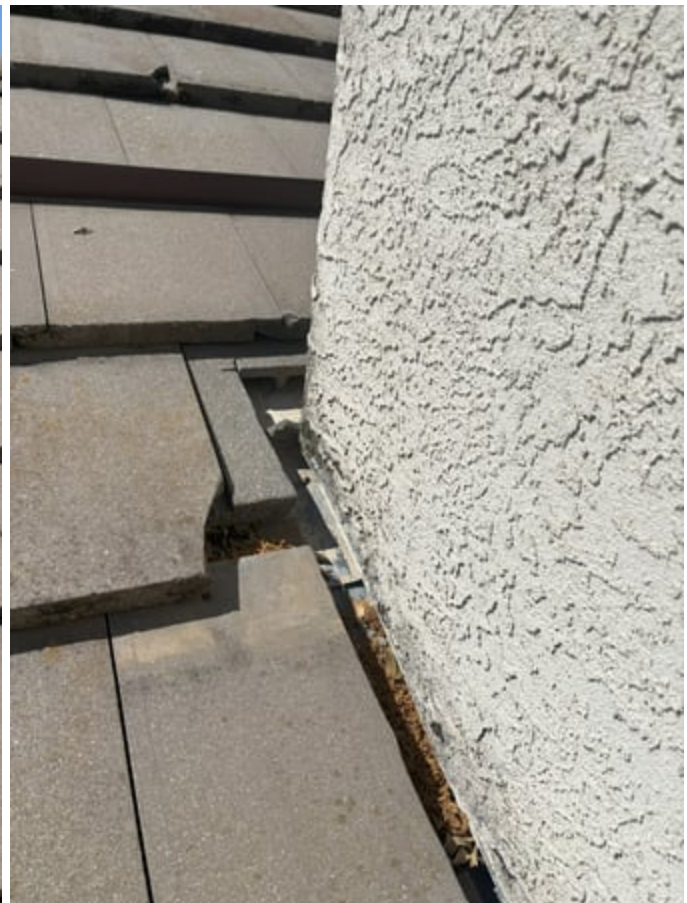
Roof-Covering Materials

Major Defect

The roof covering material was comprised of concrete tiles that had a tongue and groove interlocking system. I observed several of the tiles had been chipped or cracked. Some of the tiles had slid apart from their original positions. There were several exposed fastener tips above the tiles. These exposed fastener heads can lead to water intrusion going under the roof covering materials. There were spots of algae on the roof. I observed many small divots or dents in the roof tiles. These

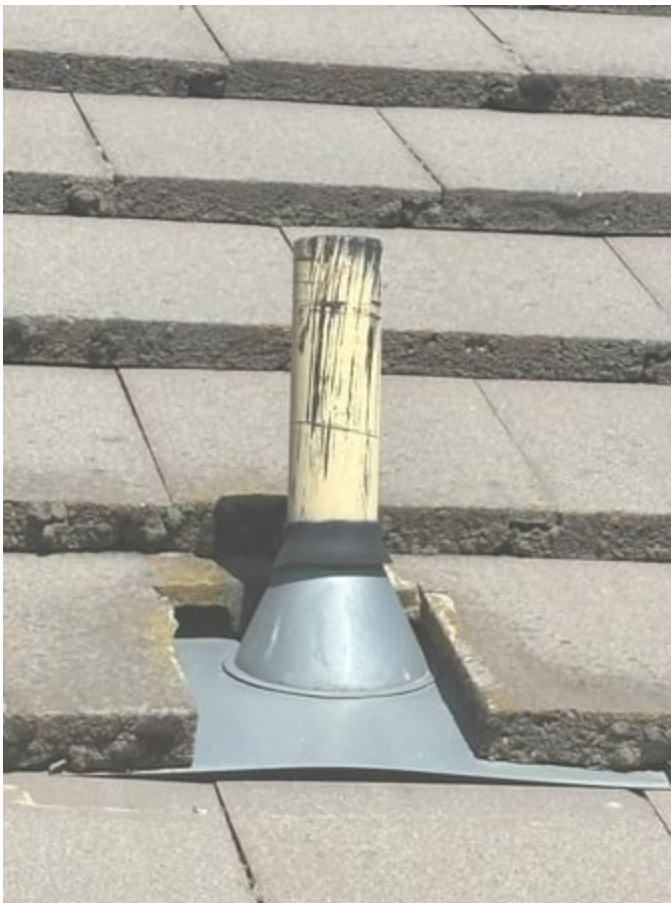
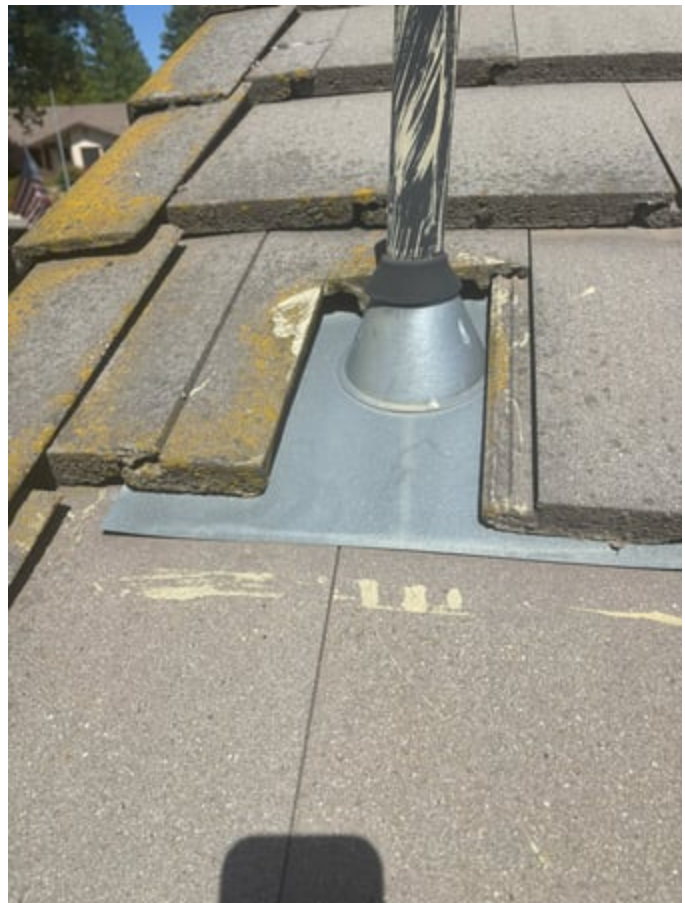
Vents, Flashing, Skylights, Chimney, and Other Roof Penetrations

Major Defect

Vent stack flashing was not secured completely to the roof system and had a small gap on the bottom it which could allow for moisture intrusion.

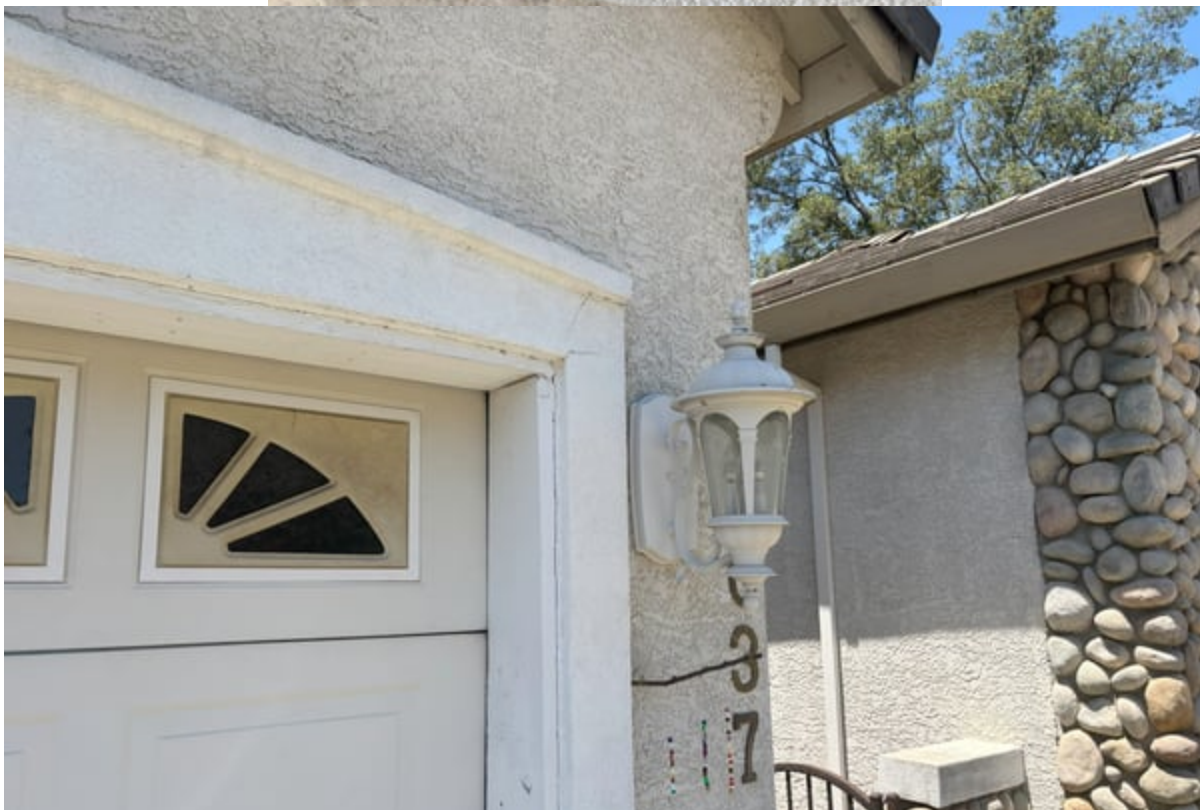
Exterior Wall-Covering Materials

Major Defect

The wall covering material was made of primarily stucco material. I observed several cracks in the material around the house exterior. A licensed professional should be retained to make the necessary corrections.

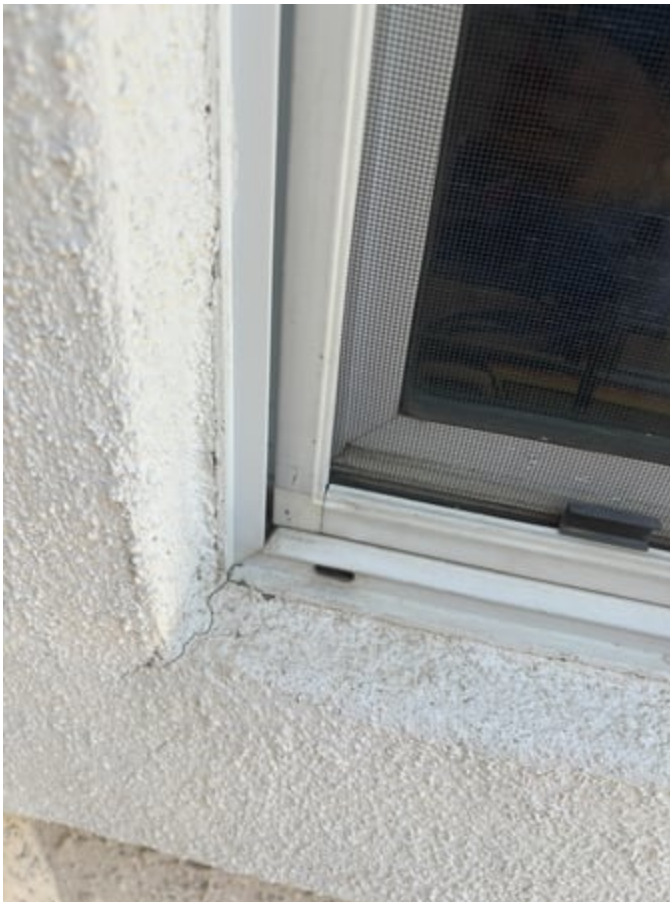
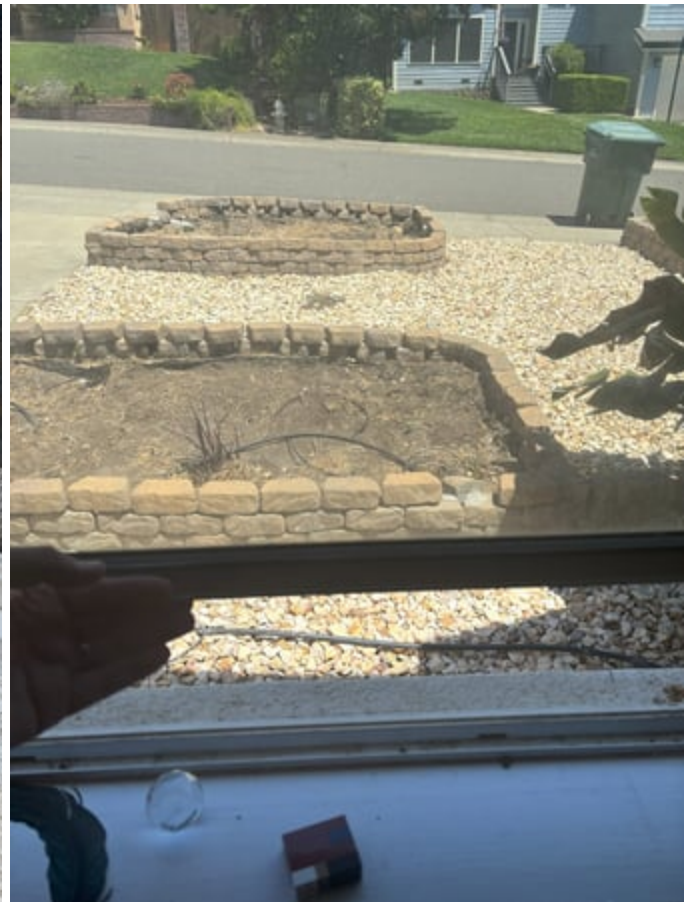
Windows (a representative number)

Major Defect

I observed some cracking around the exterior of one of the windows. A licensed professional should be retained to make the necessary corrections to prevent water intrusion.

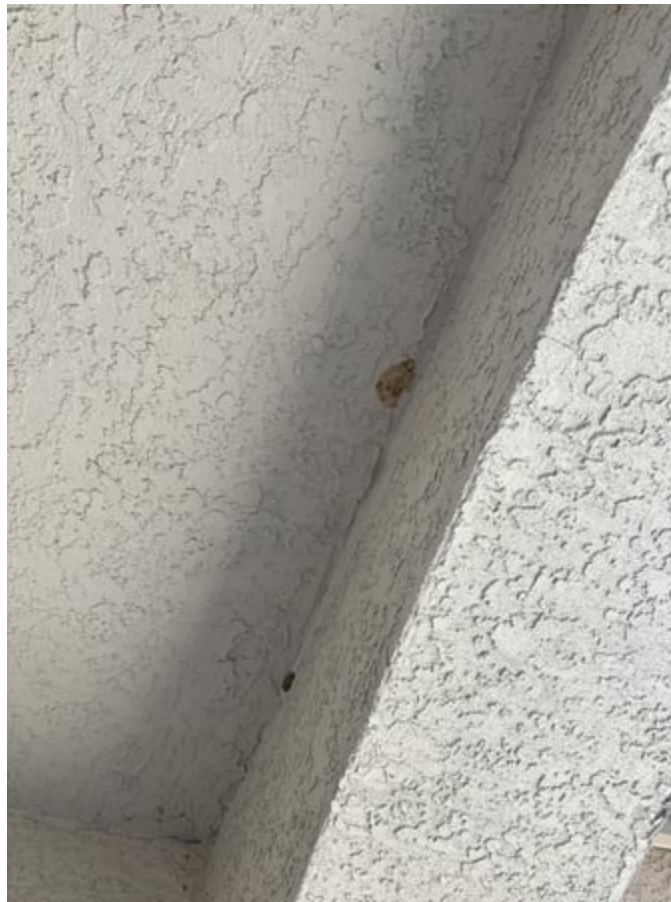
Porches, Patios, Decks, Balconies and Carports

Major Defect

I observed signs of water intrusion in the ceiling of the front porch. There was a rust colored water spots on the ceiling. This is concerning because it is unknown where the possible water damage is coming from. A licensed professional should investigate further and make the necessary corrections

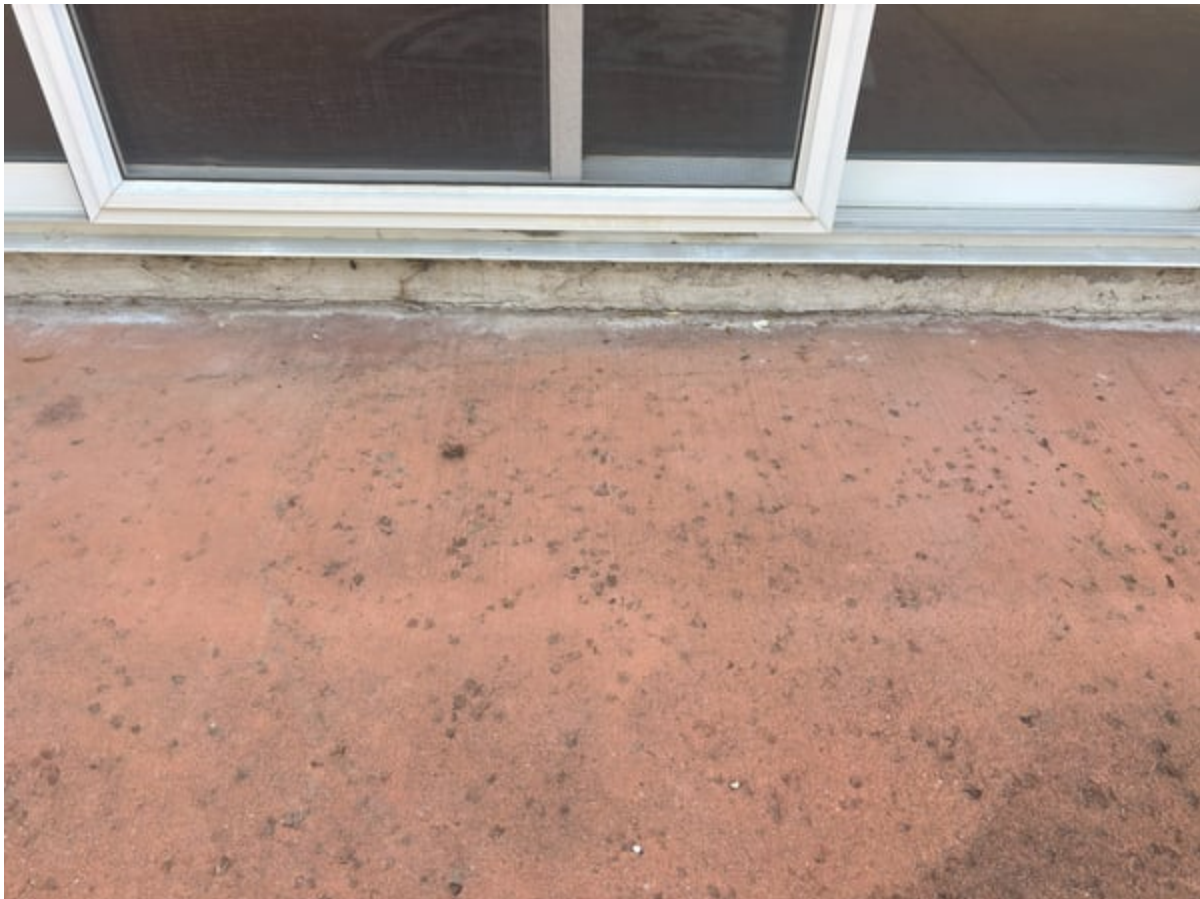
Foundation

Major Defect

I observed a large crack on the foundation near the back sliding glass door. This crack could allow for moisture intrusion into the foundation. It is concerning the crack ran the entire length of the door. However, there were no other signs of moisture intrusion in that area of the home. A licensed professional should be retained to investigate further and make the necessary corrections.

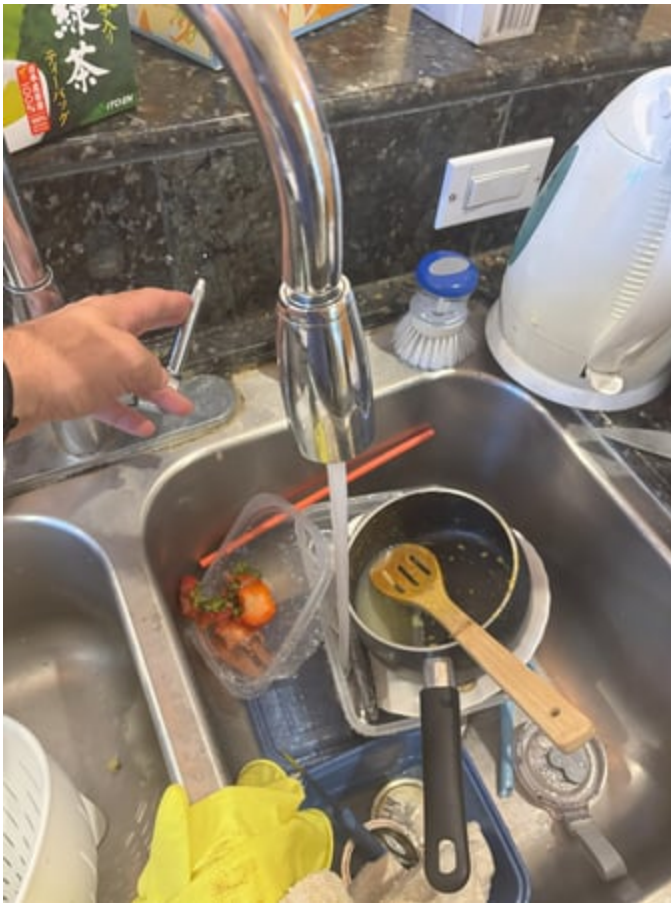
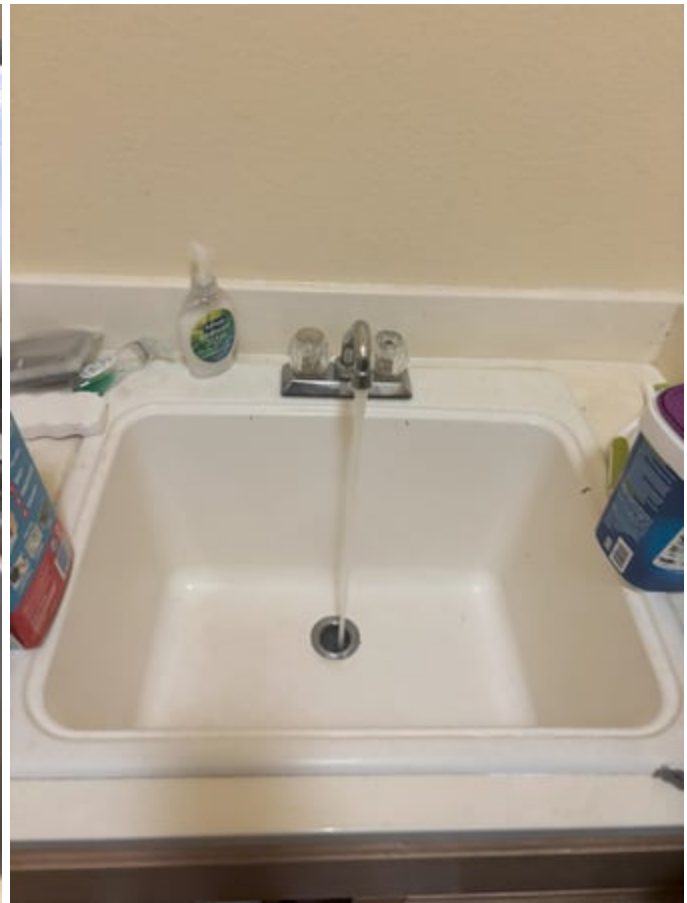
Interior Water Supply (including all fixtures and faucets, by running the water)

Minor Defect

Garage utility sink cold water did not turn on. It is recommended a licensed plumber be retained to make the necessary corrections.

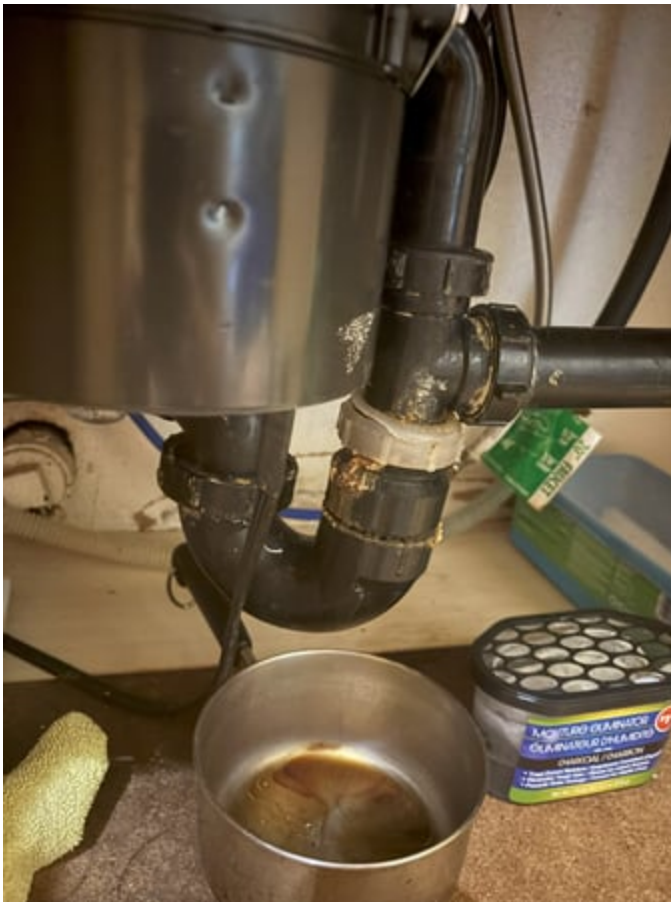
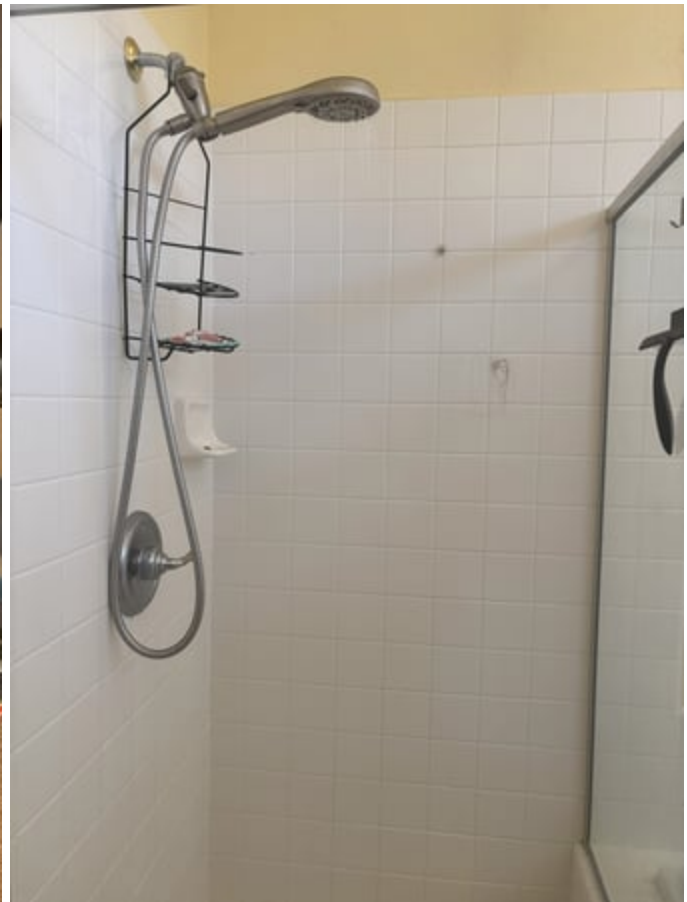
All Sinks, Tubs and Showers (for functional drainage)

Major Defect

Under the kitchen sink I observed a metal pot placed under the sink drain. The cabinet under the pot was chipped and had signs of water damage including being soft to the touch. There was a crack in the tailpiece of the drain next to the P trap. A licensed plumber should be retained to make the necessary corrections.

Active water leak under the kitchen sink. A licensed professional should be retained to make the necessary corrections.

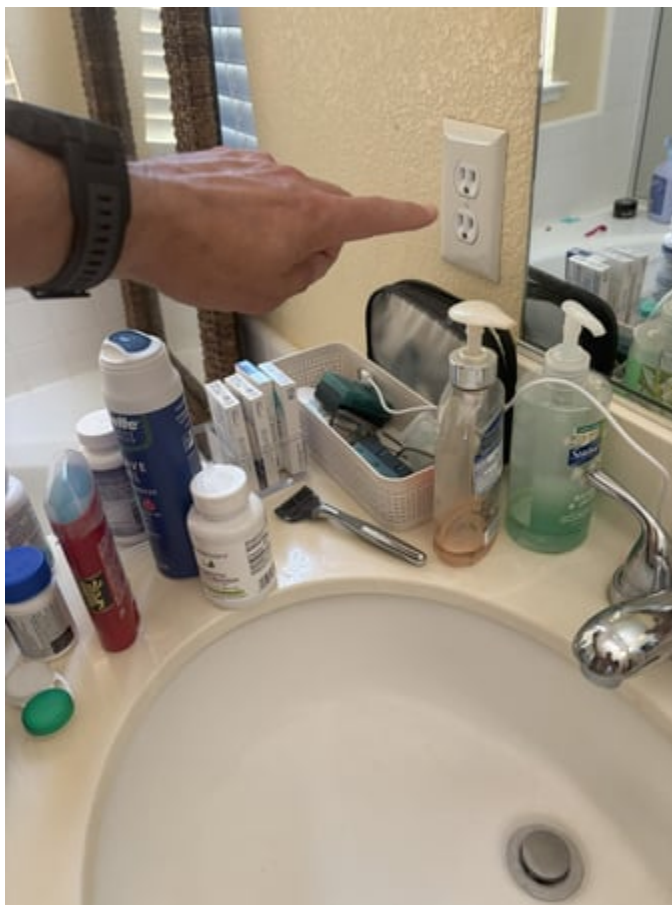
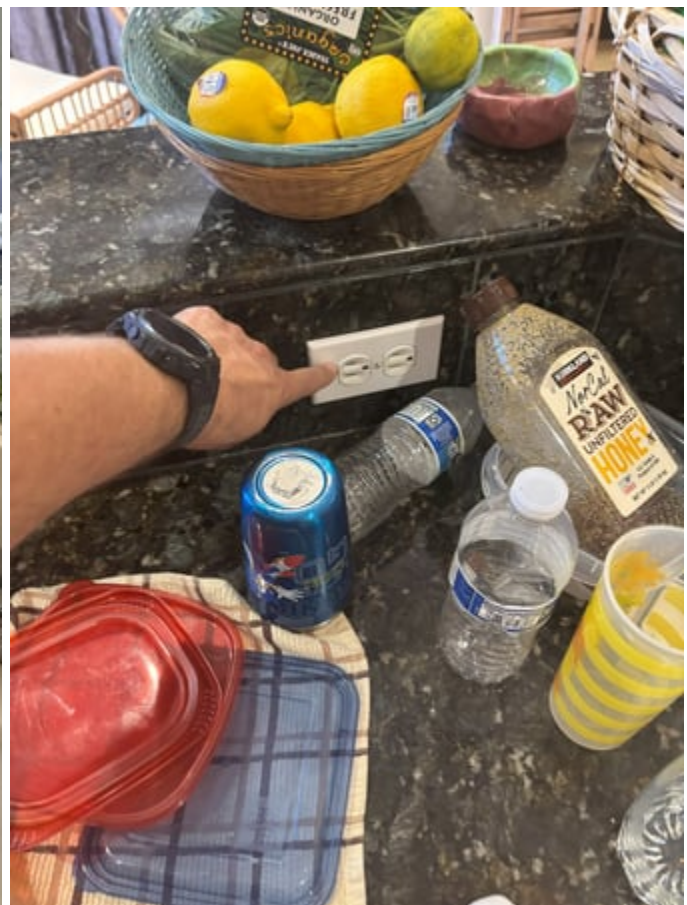
Major Defect

No GFCI outlets were installed in the bathrooms or the kitchen near the sink. A licensed professional should be retained to make the necessary corrections.

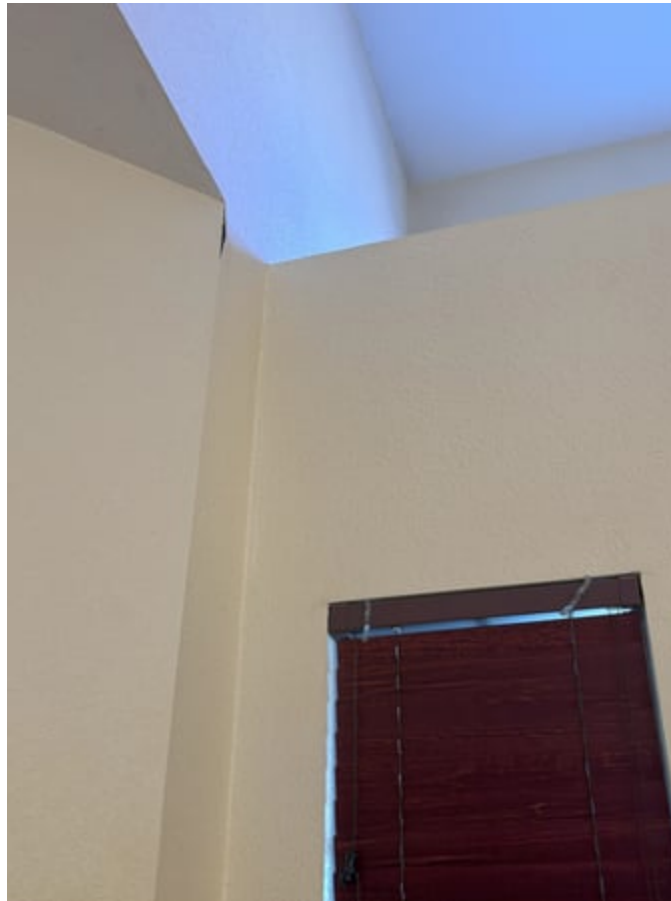
Minor Defect

I located a crack in the drywall in the front room of the home. It is recommended a licensed professional investigate it further.
