Mock Inspection Report

5037 Chicago Avenue, Fair Oaks, CA, USA

Jul 2, 2025

Performed by **David Erler**

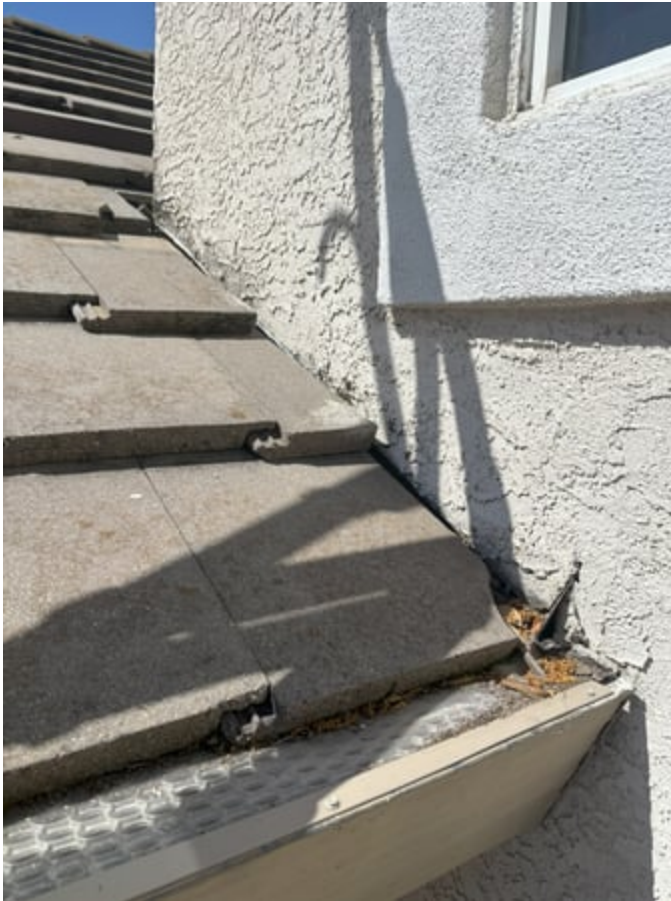
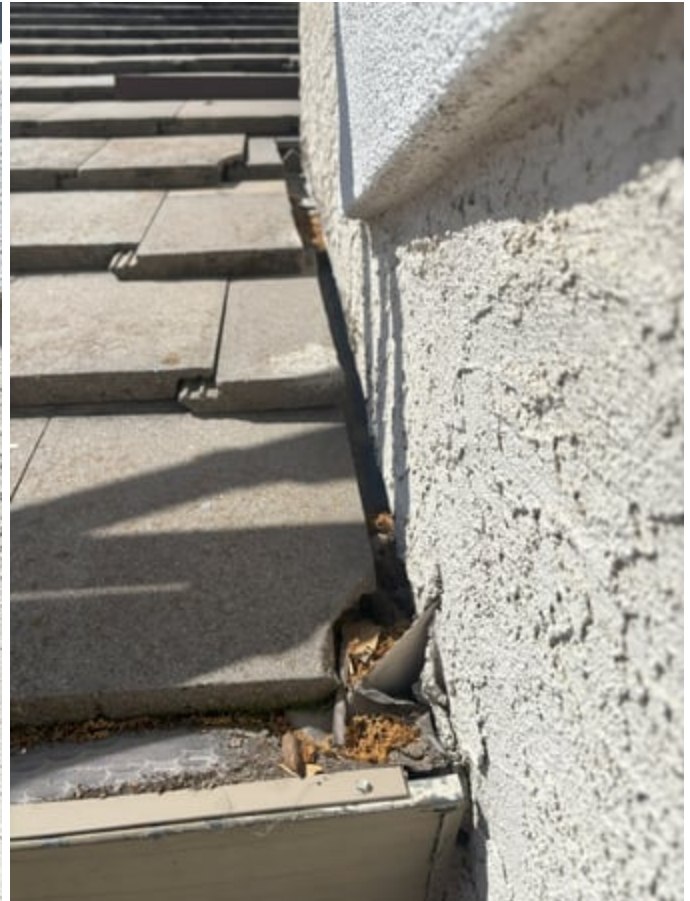
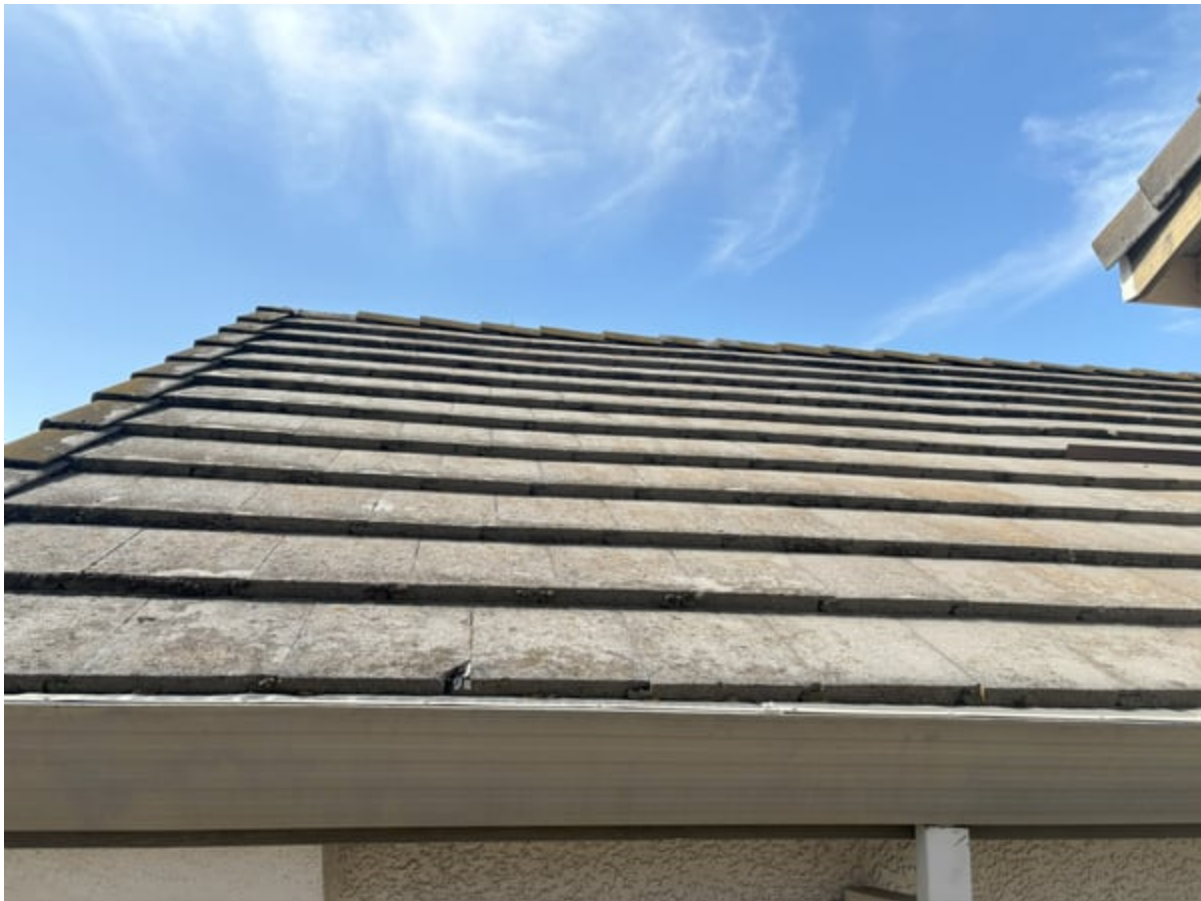
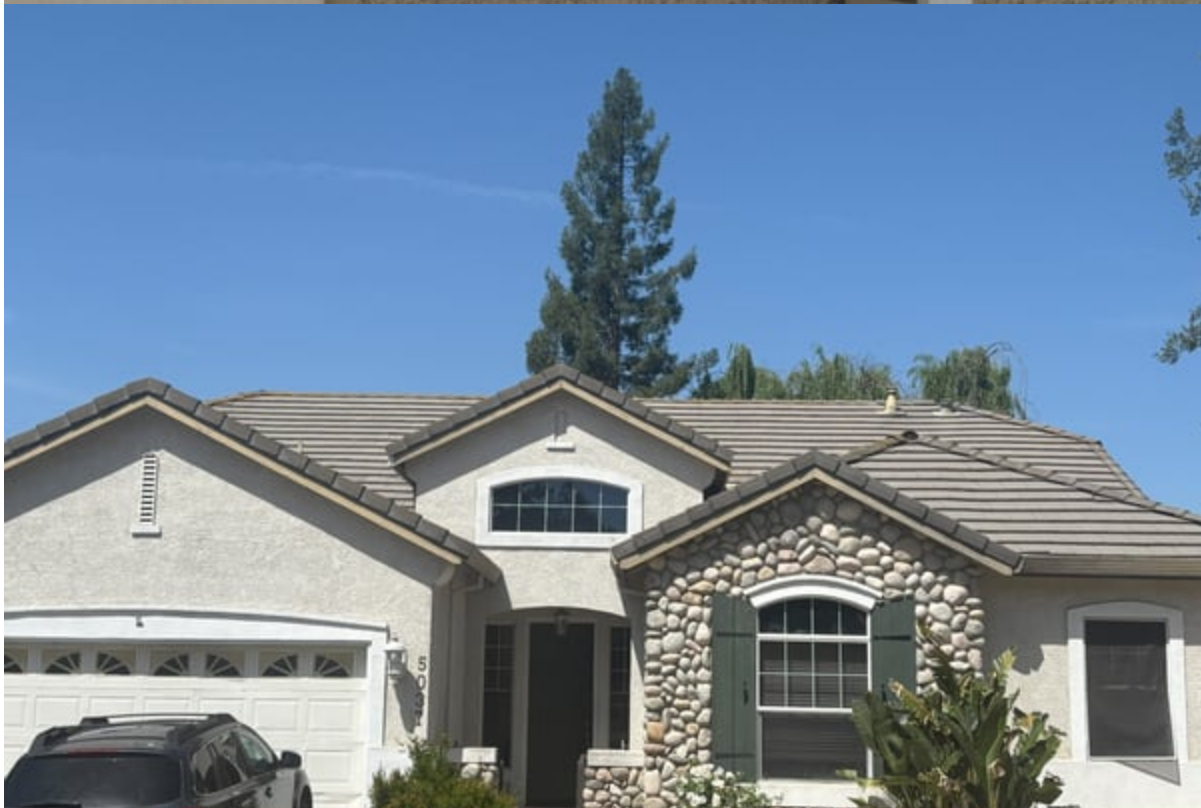
Roof-Covering Materials

Major Defect

The roof covering material was comprised of concrete tiles that had a tongue and groove interlocking system. I observed several of the tiles had been chipped or cracked. Some of the tiles had slid apart from their original positions. There were several exposed fastener tips above the tiles. These exposed fastener heads can lead to water intrusion going under the roof covering materials. There were spots of algae on the roof. I observed many small divots or dents in the roof tiles. These

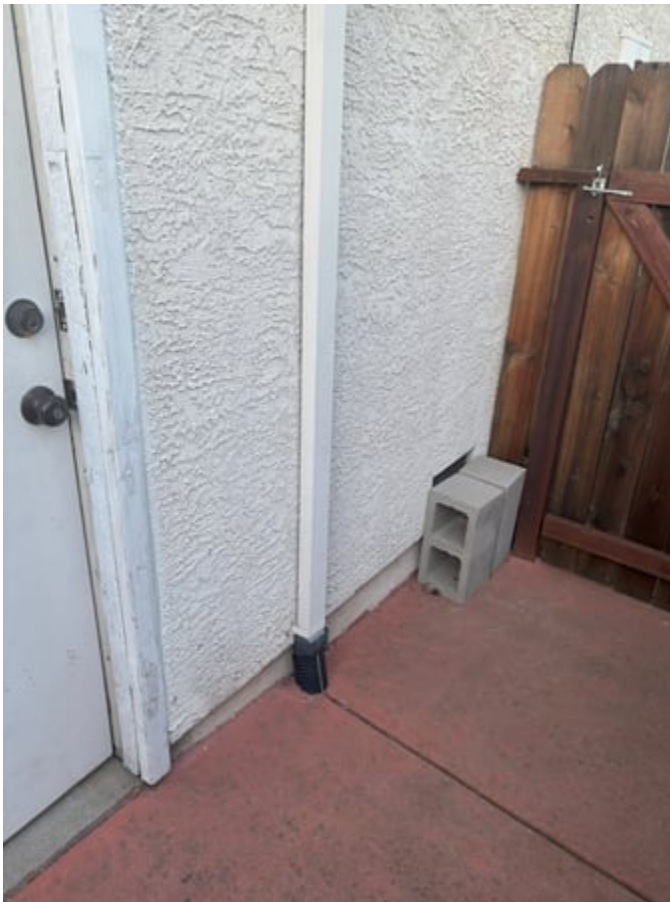
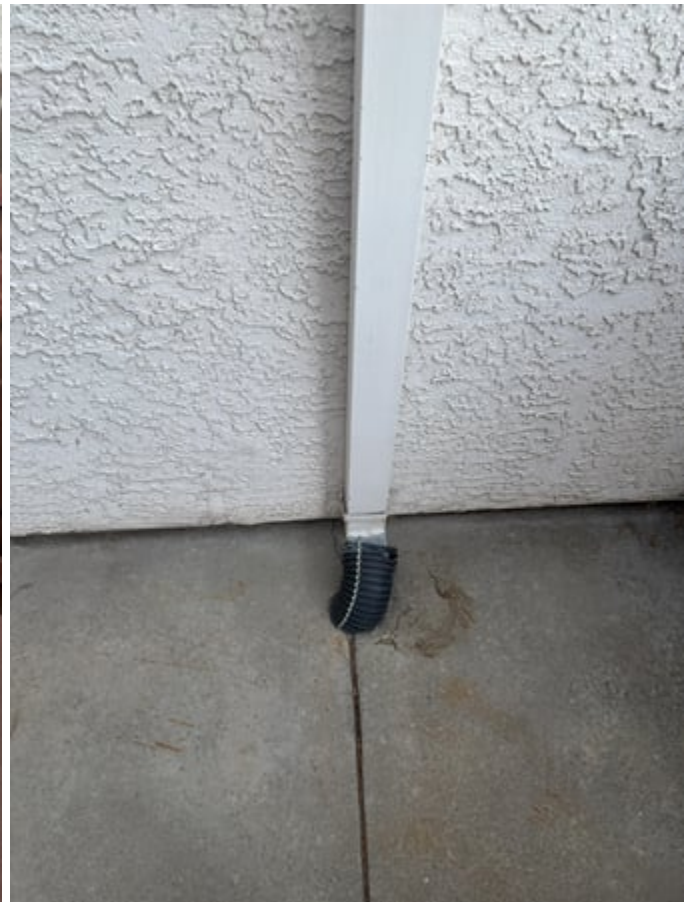
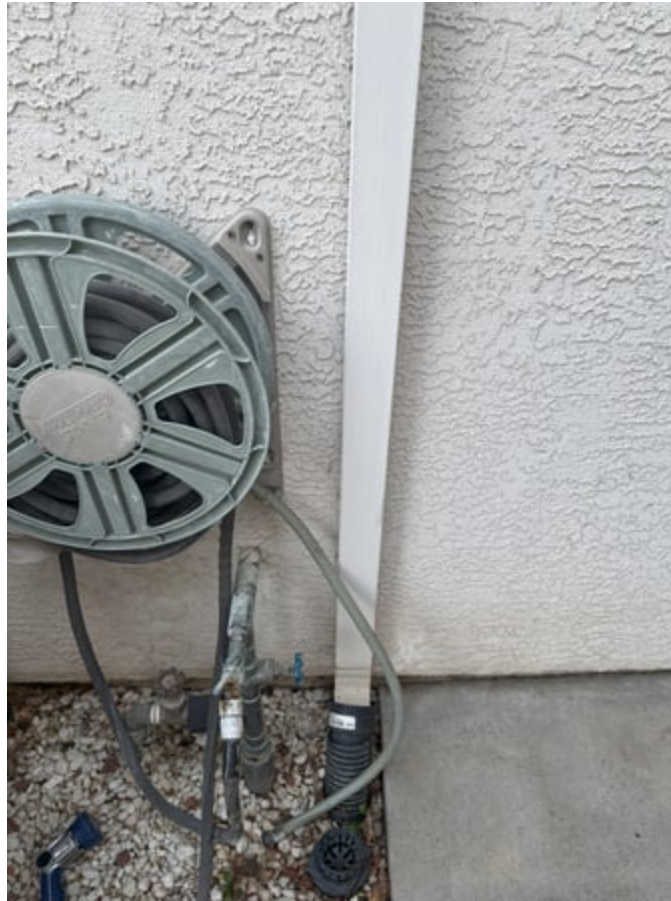
Downspouts appeared to be in good working order. All of them appeared to be installed properly and were attached to a piped drainage system diverting water from the home.

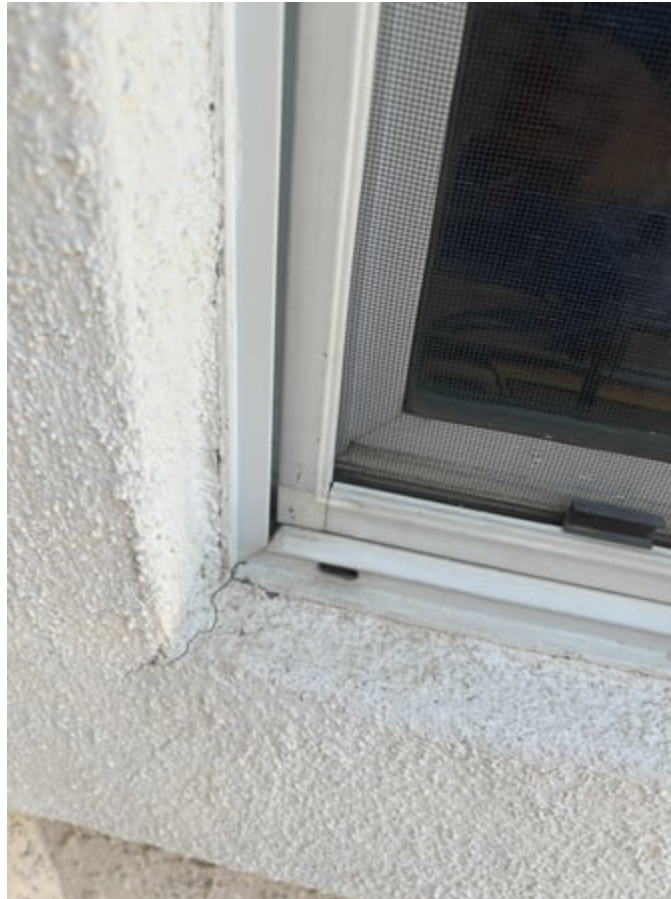
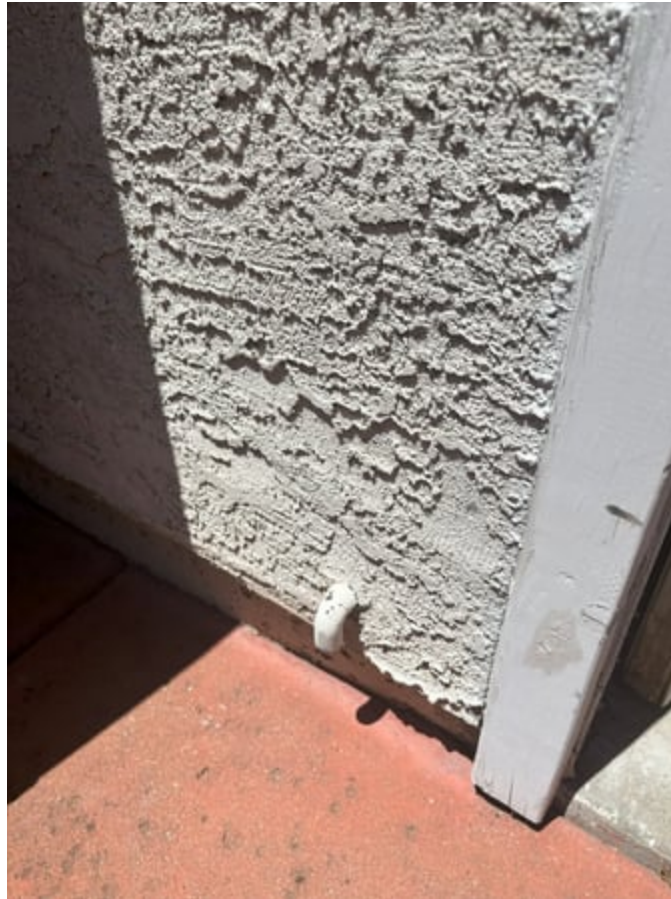
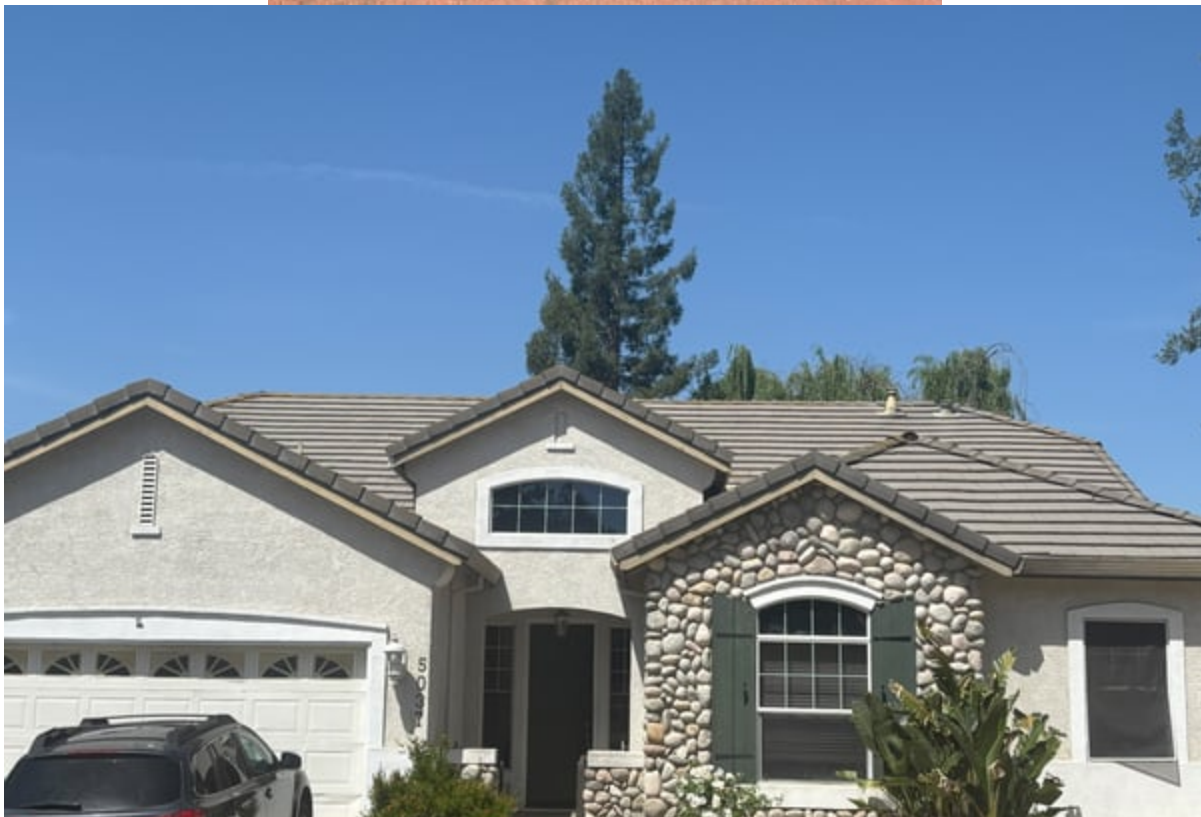
Major Defect

The wall covering material was made of primarily stucco material. I observed several cracks in the material around the house exterior. A licensed professional should be retained to make the necessary corrections.

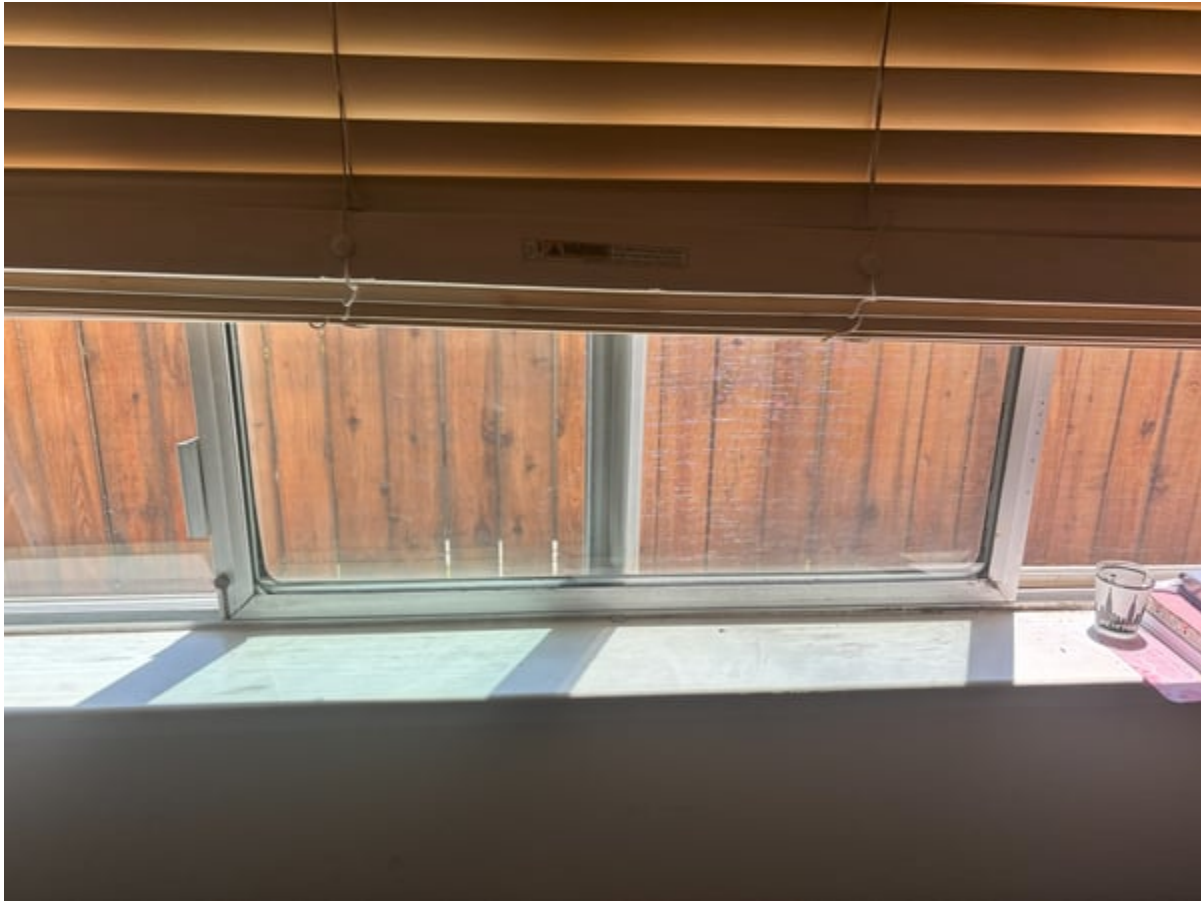
Windows (a representative number)

Major Defect

I observed some cracking around the exterior of one of the windows. A licensed professional should be retained to make the necessary corrections to prevent water intrusion.

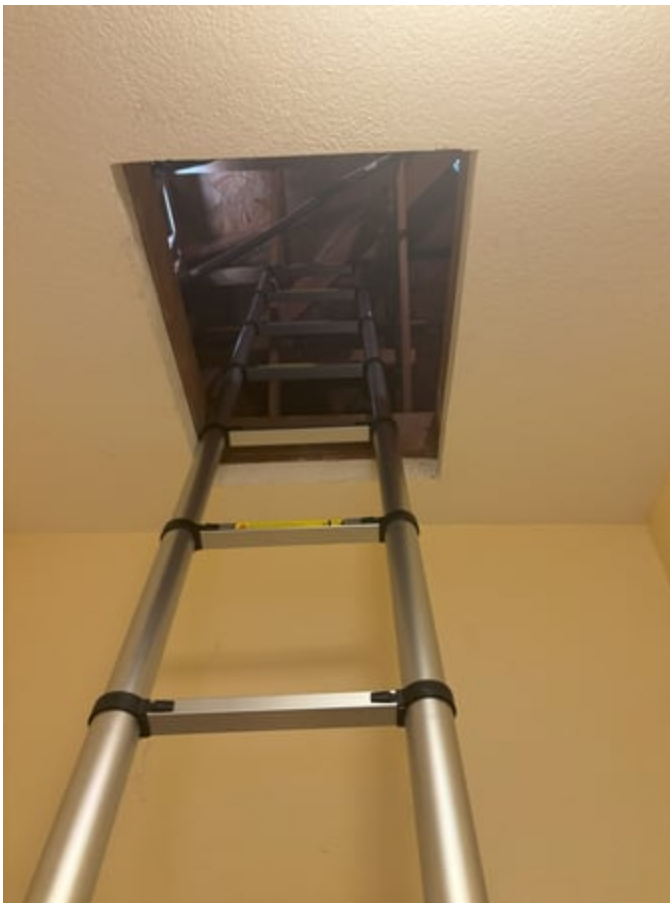
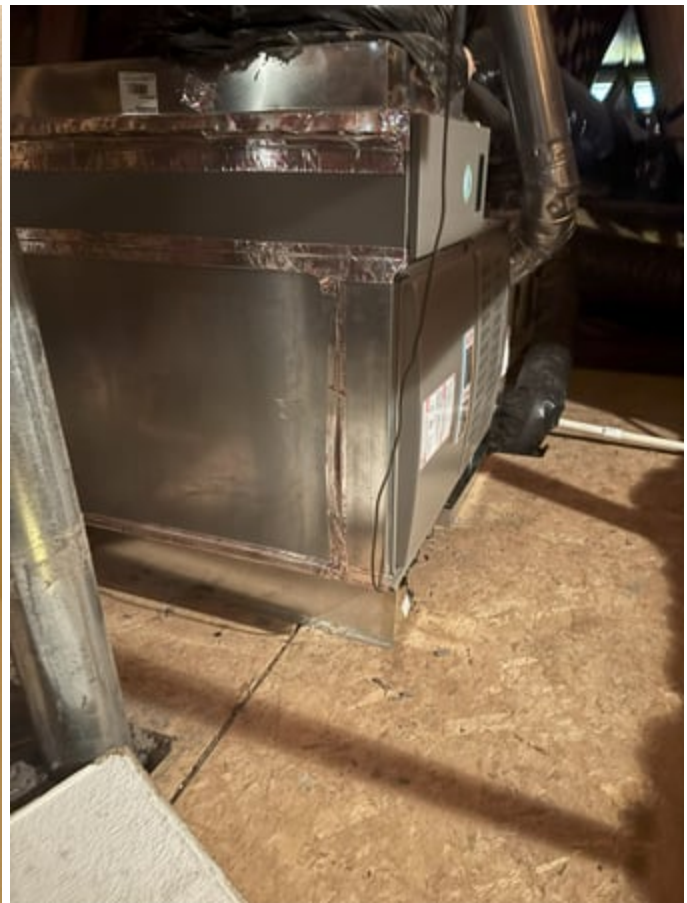
Heating system was a forced air heat pump as part of the HVAC system. The system was located in the attic. Access was from the closet in the master bedroom.

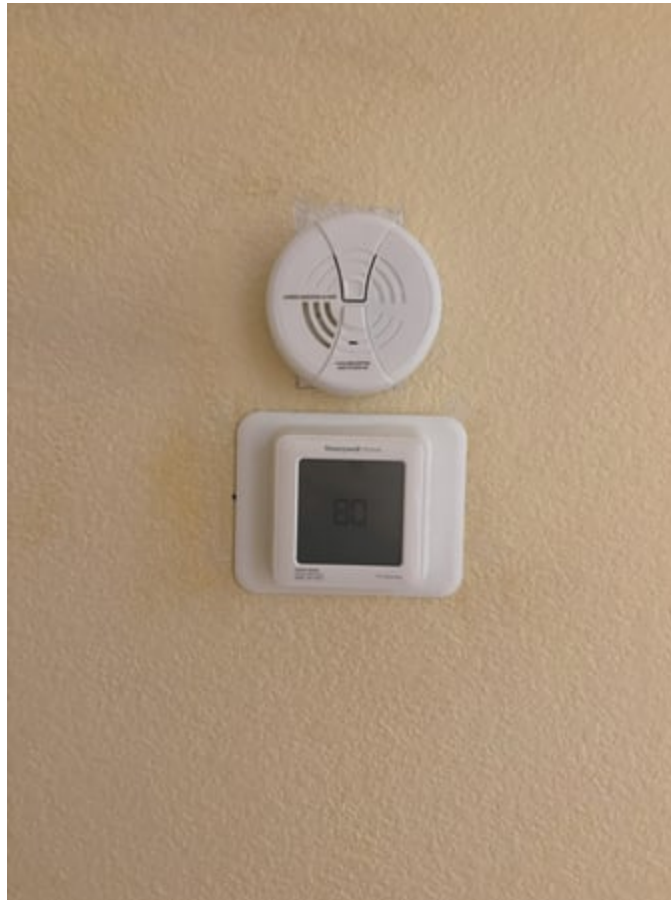
Location of the Thermostat for the Heating System

- The thermostat was centrally located in the hallway of the home and was easily accessible. The thermostat was operable and appeared to work as designed.

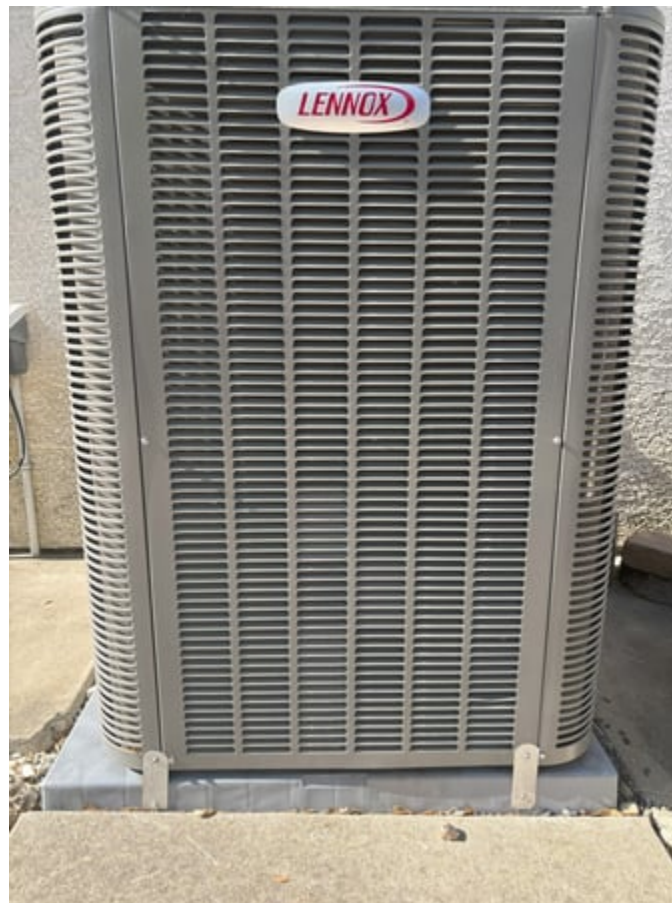
The cooling system for the home was an air conditioning system as part of the forced air HVAC system.

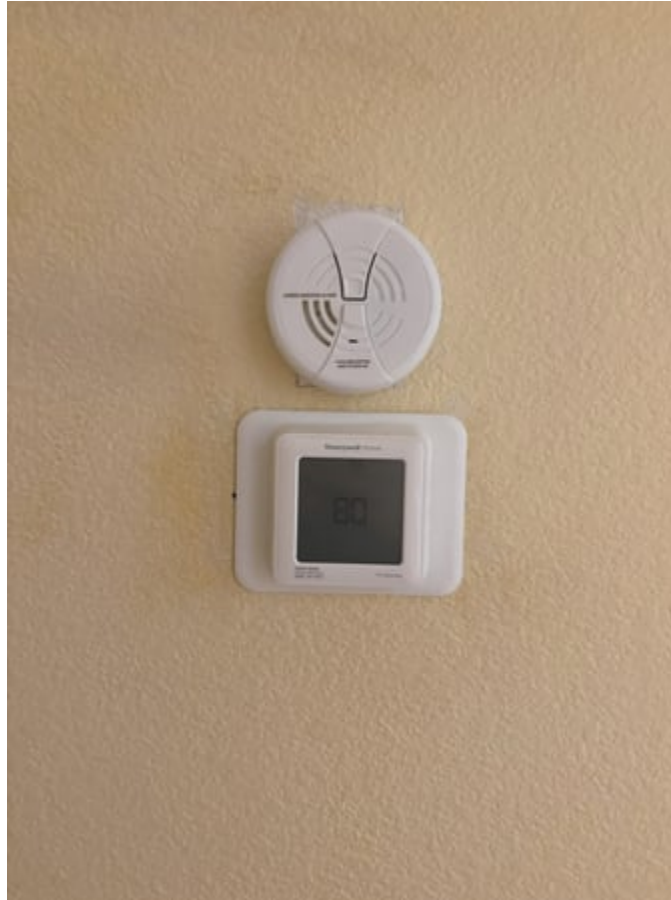
The Location of the Thermostat for the Cooling System

- The thermostat was centrally located in the hallway and worked using the normal operating controls.

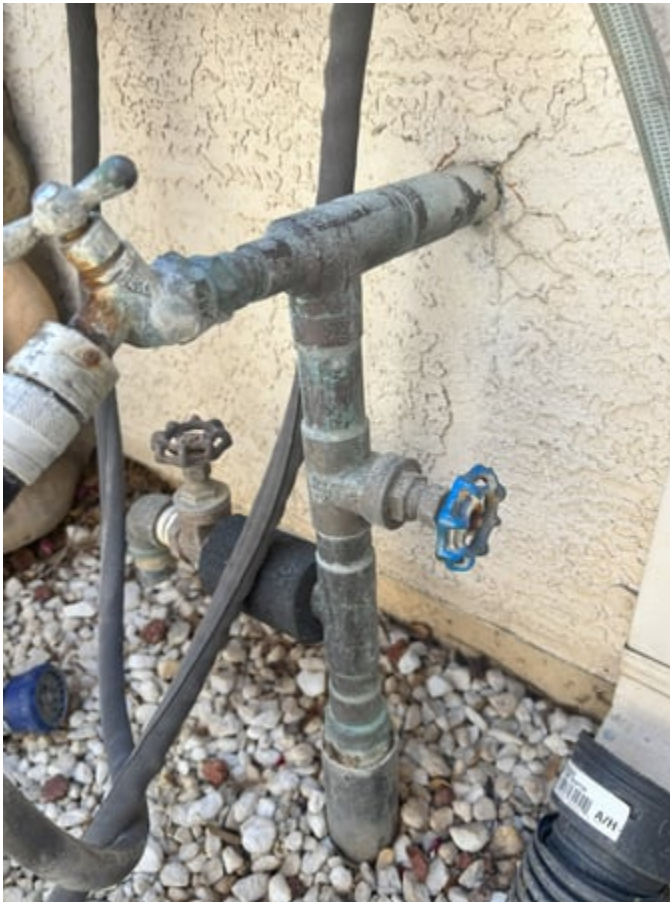
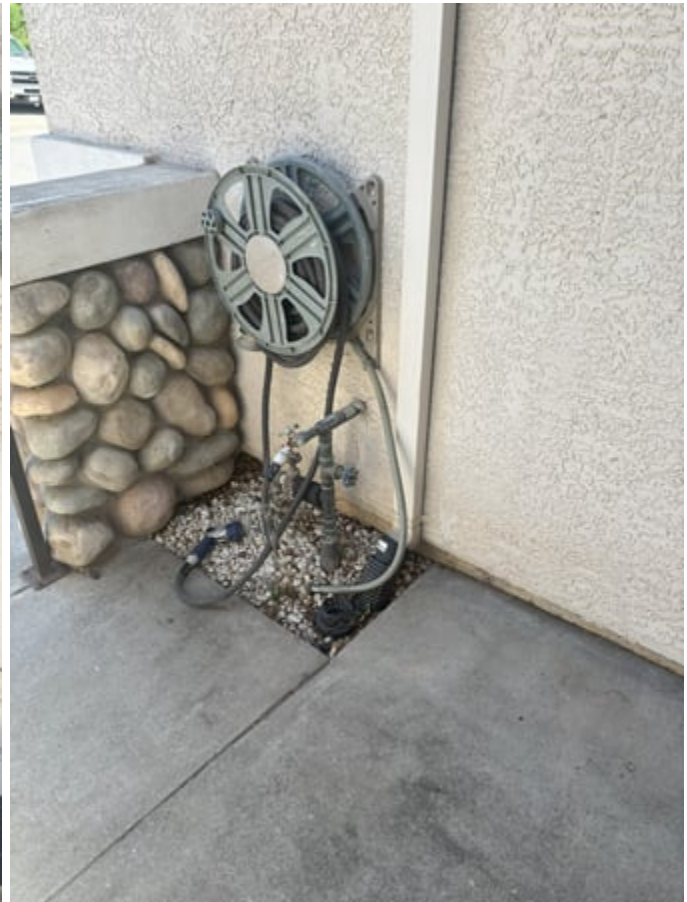
The main water shut-off was located in the front of the house near the walkway leading to the front door of the home.

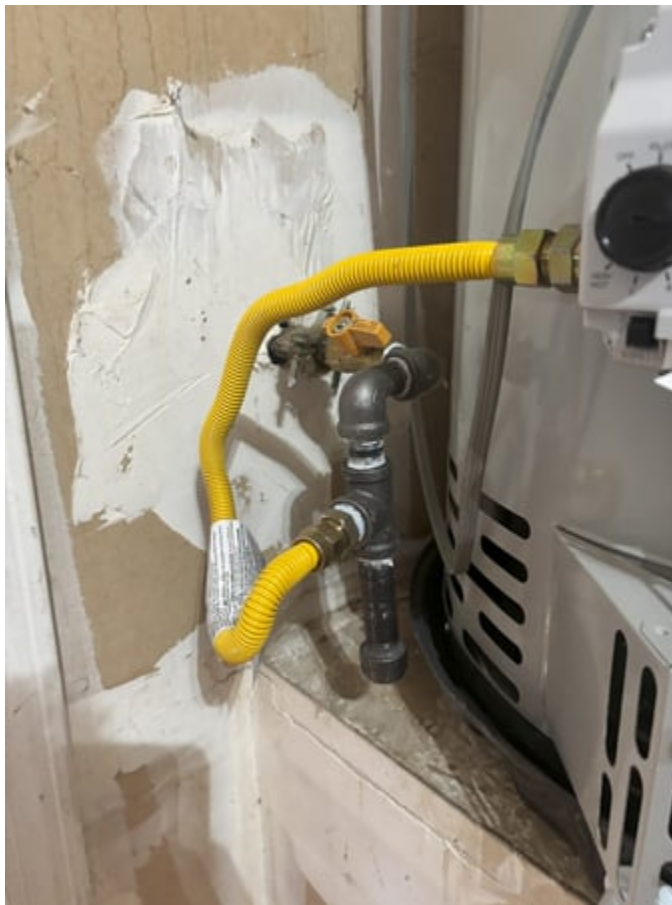
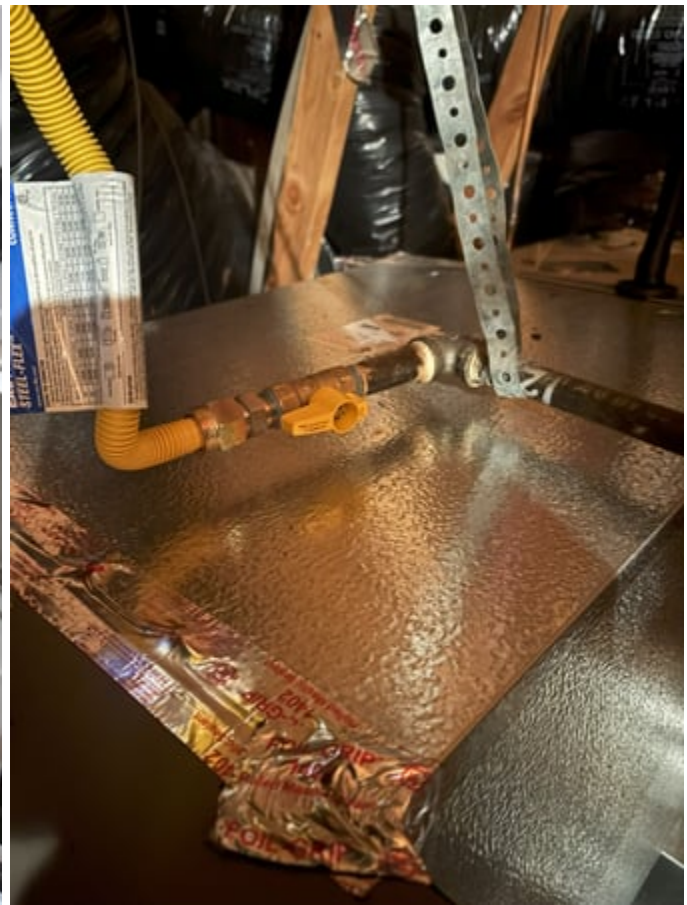
Main Fuel Supply Shut-Off Valve

The gas meter and main hookup into the home was located outside on the left side. I did not observe a main shut off valve for the gas at the meter. Shur off valves were present in the kitchen under the stove range, next to the water heater, and next to the heating system.

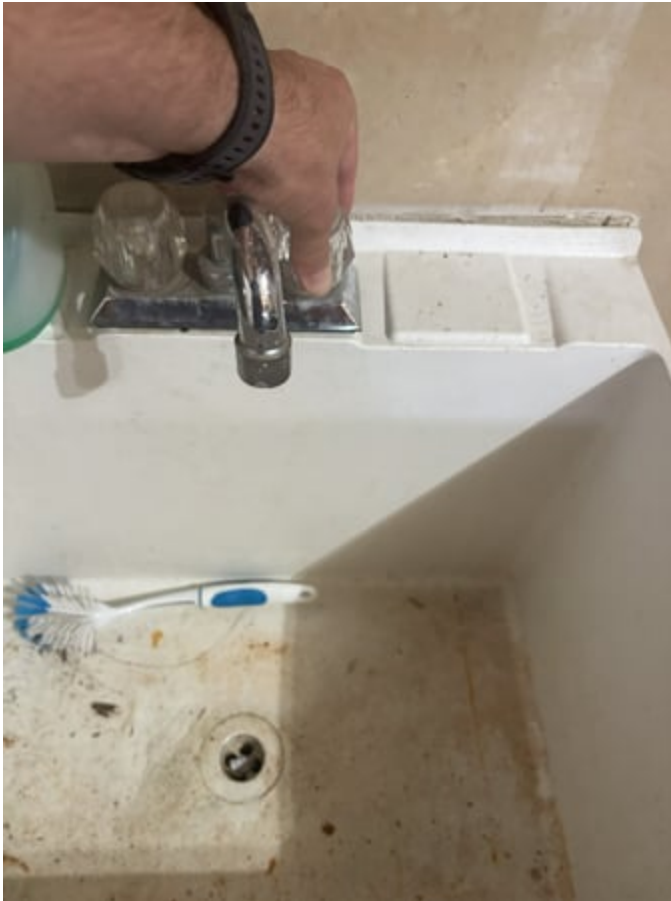
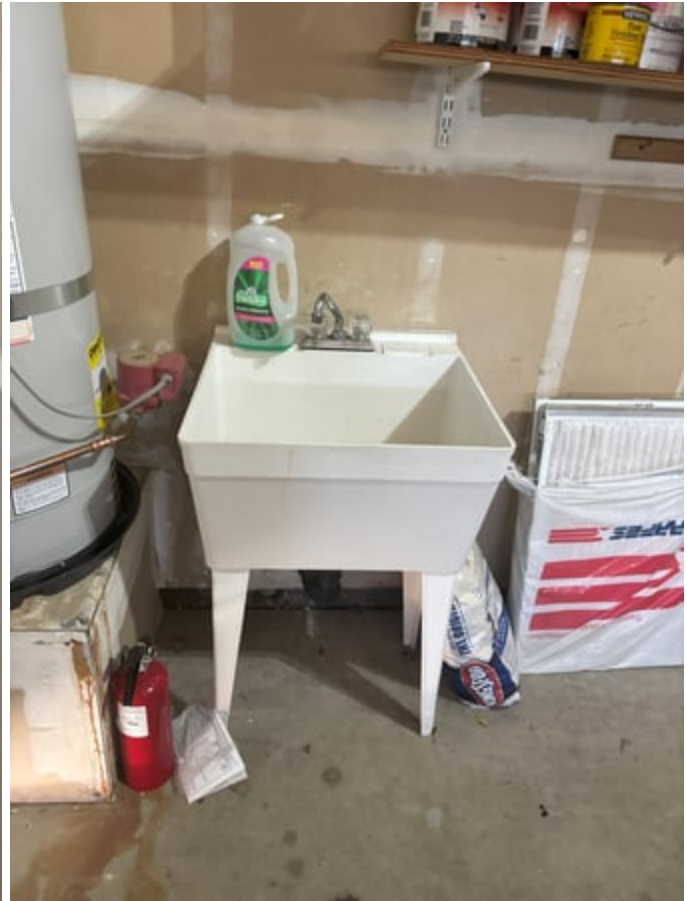
Garage utility sink cold water did not turn on. It is recommended a licensed plumber be retained to make the necessary corrections.

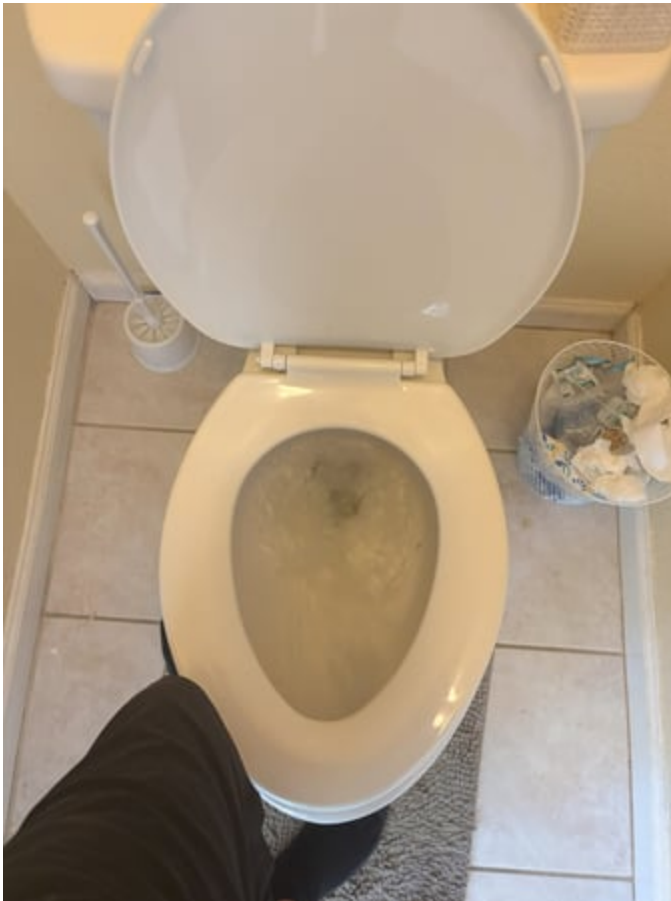
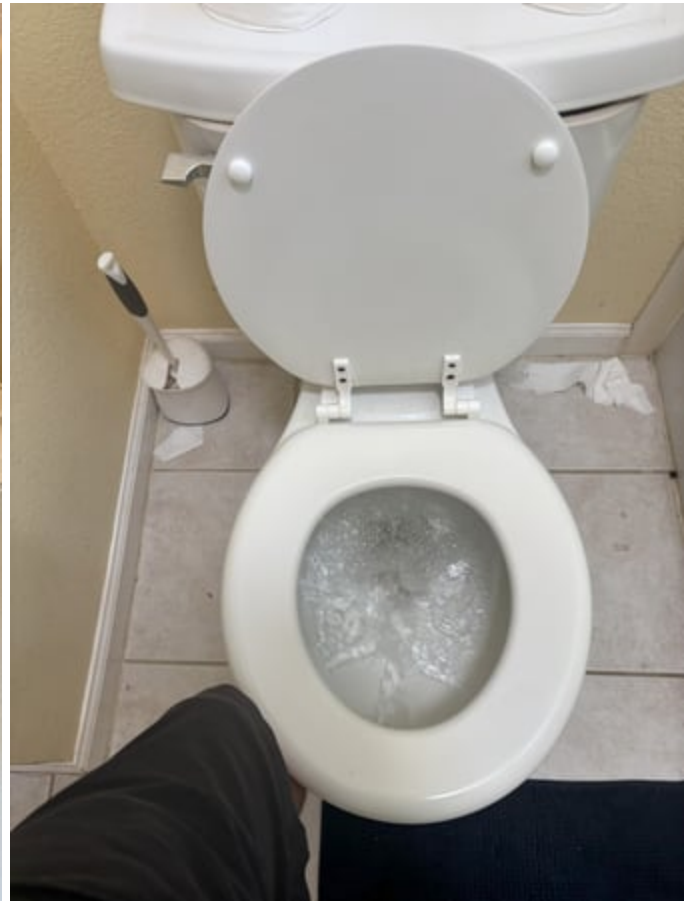
All Toilets (for proper operation by flushing)

No Defect(s) Observed

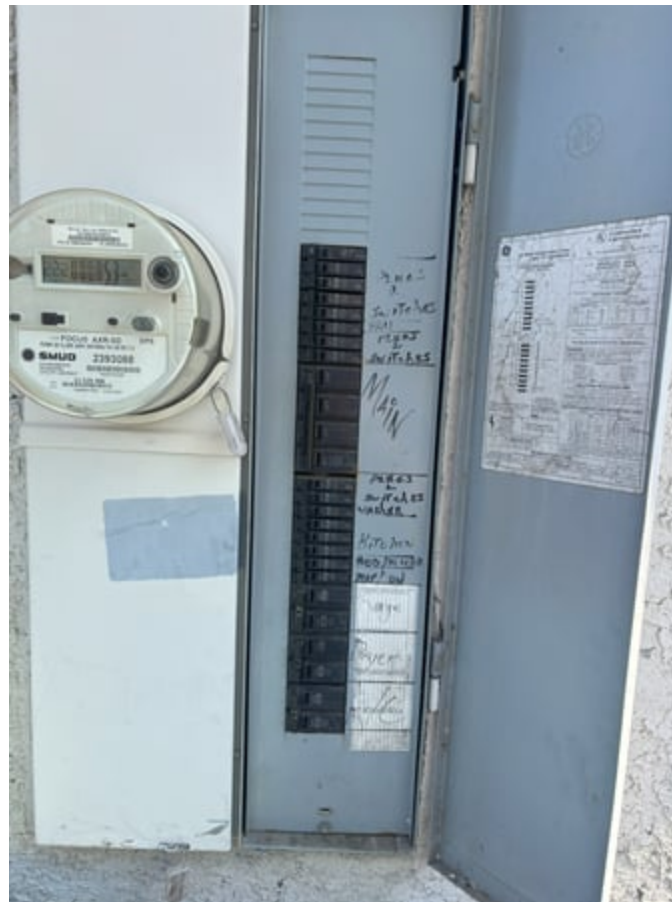
Electric Meter and Base

No Defect(s) Observed

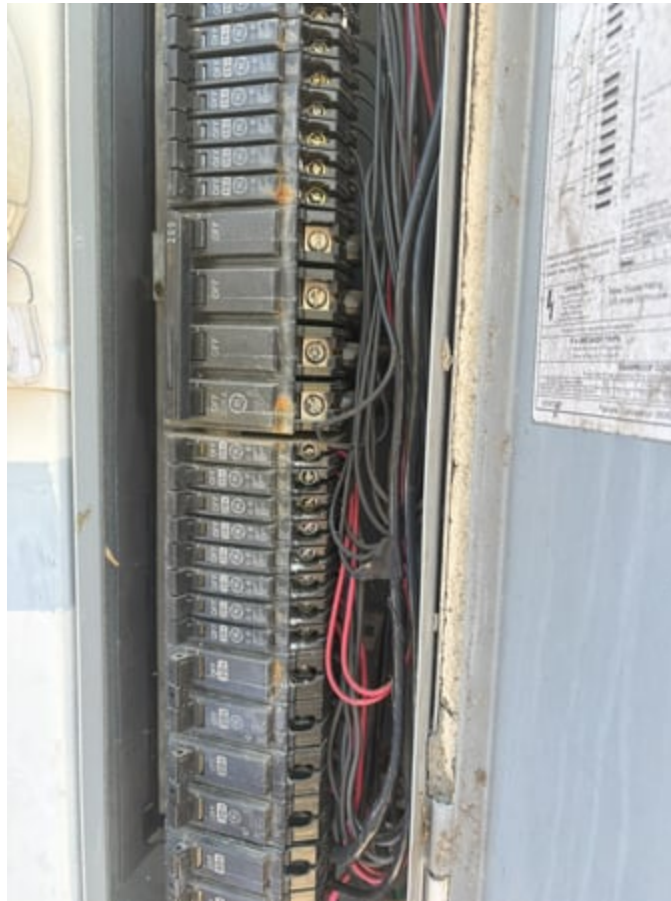
Service-Entrance Conductors

No Defect(s) Observed

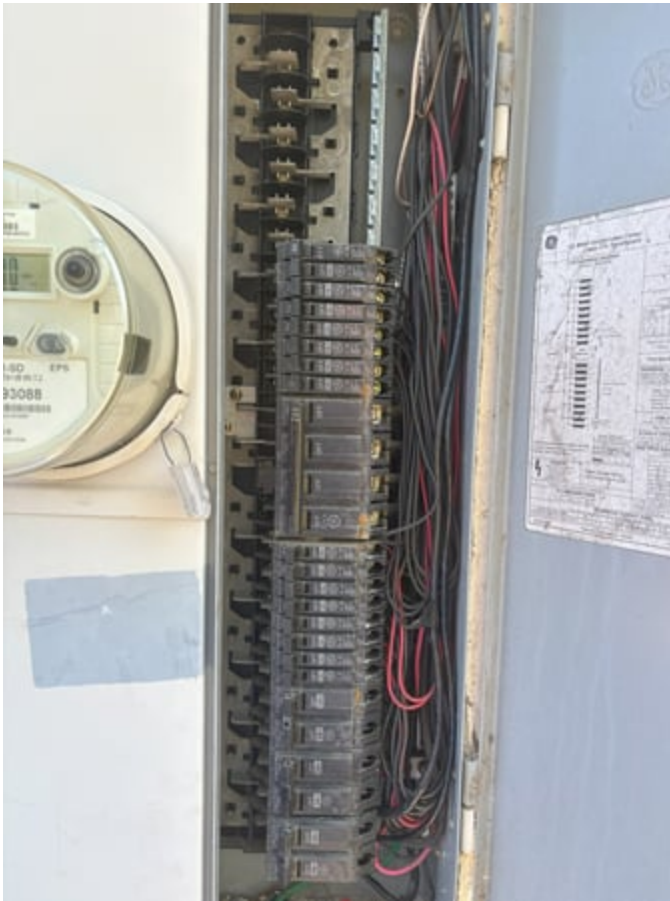
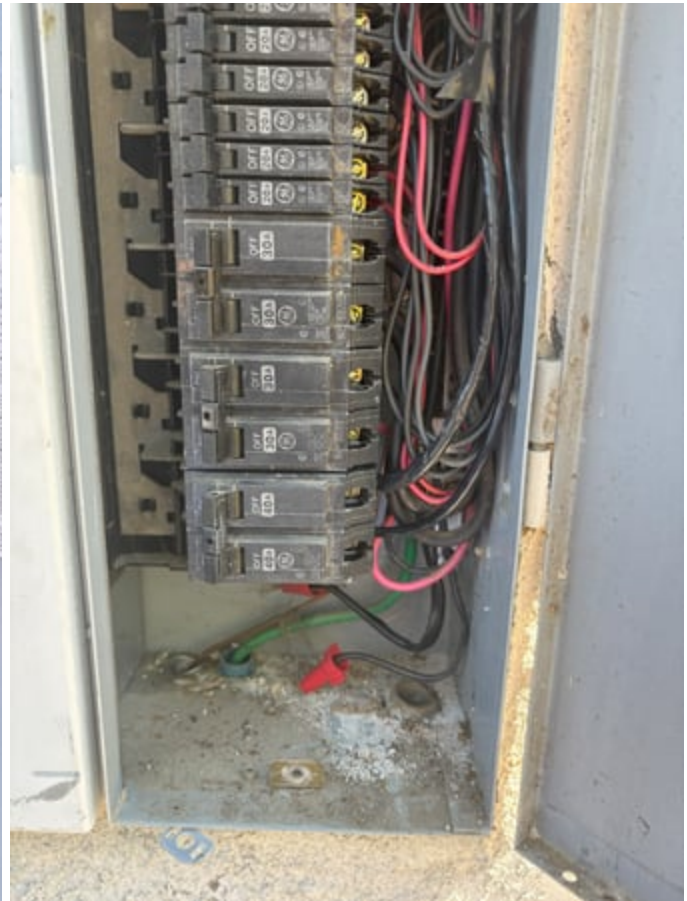
Main Service Disconnect

No Defect(s) Observed

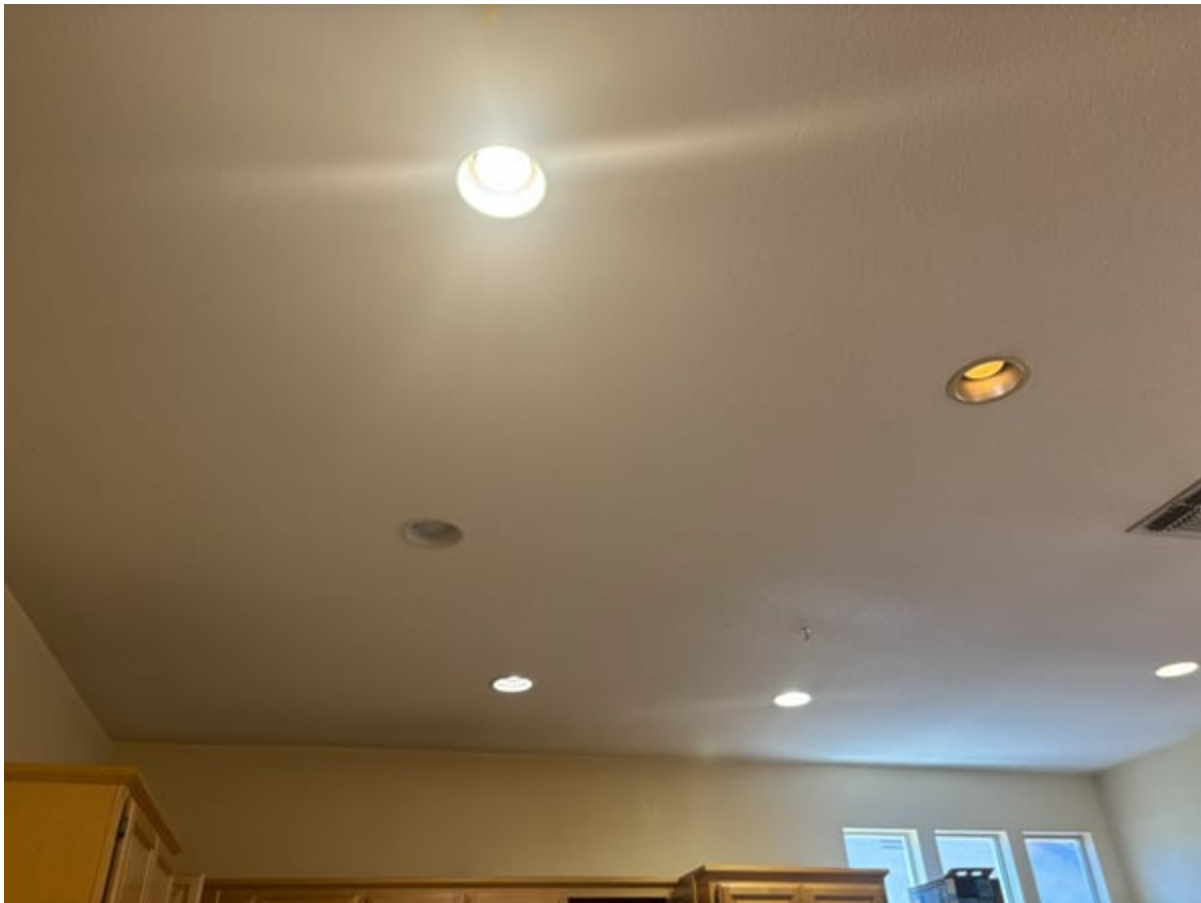
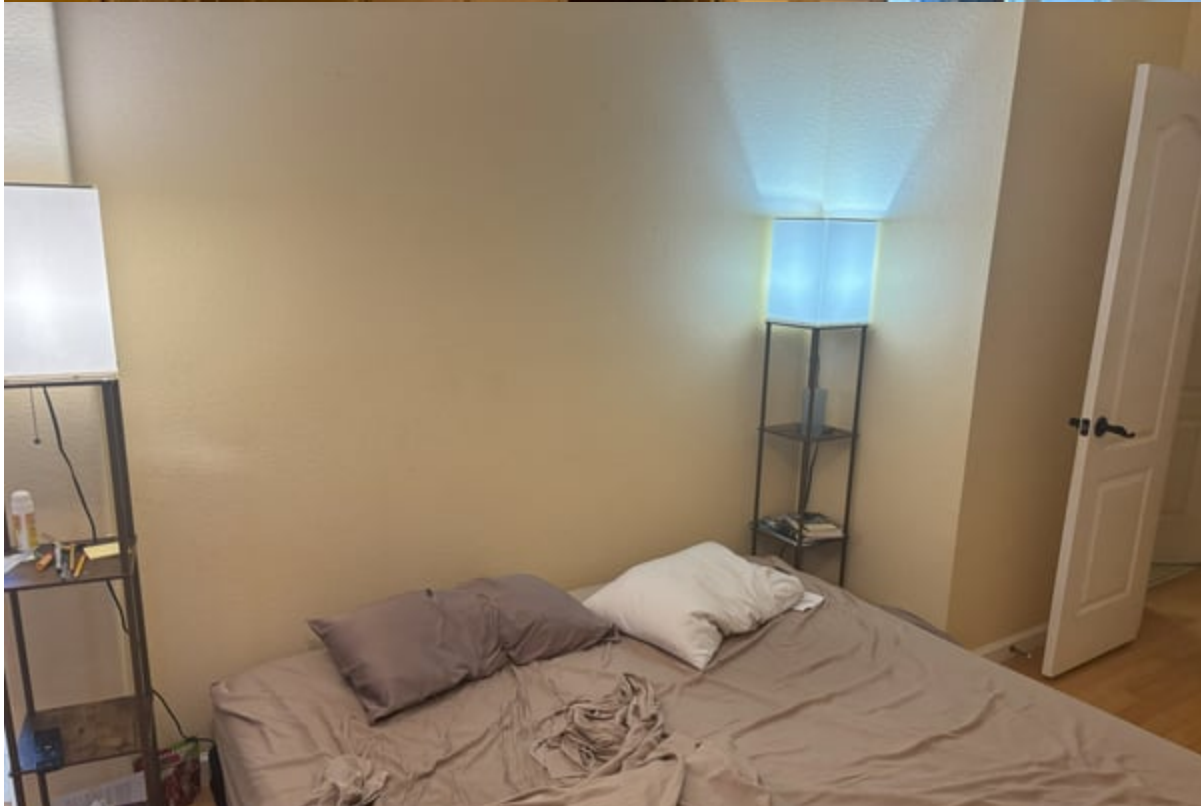
I observed one of the kitchen recessed ceiling lights did not turn on. It is unknown if the light bulb was simply out or if another problem with the electrical system exists. It is recommended corrections be made.

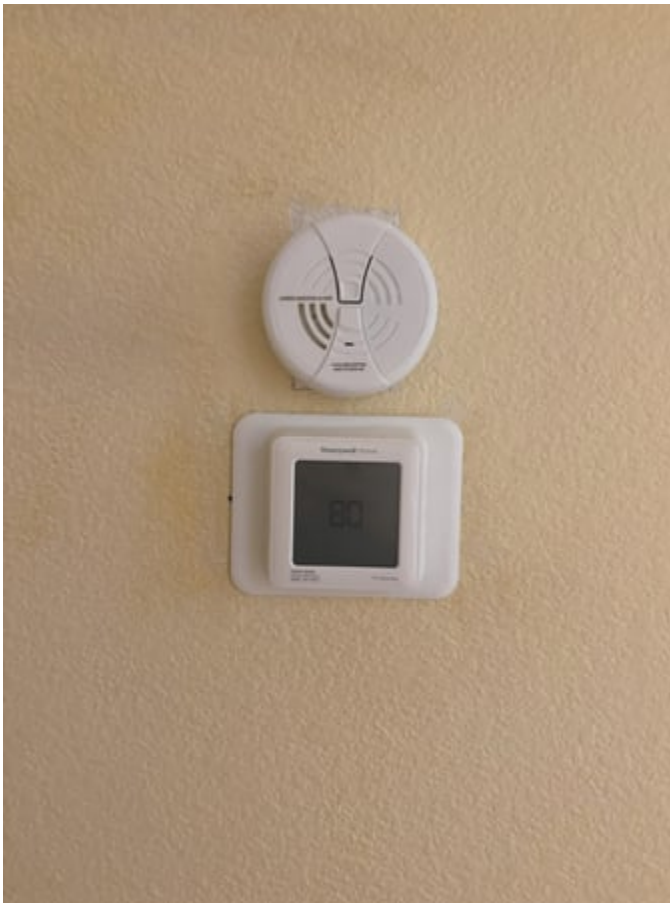
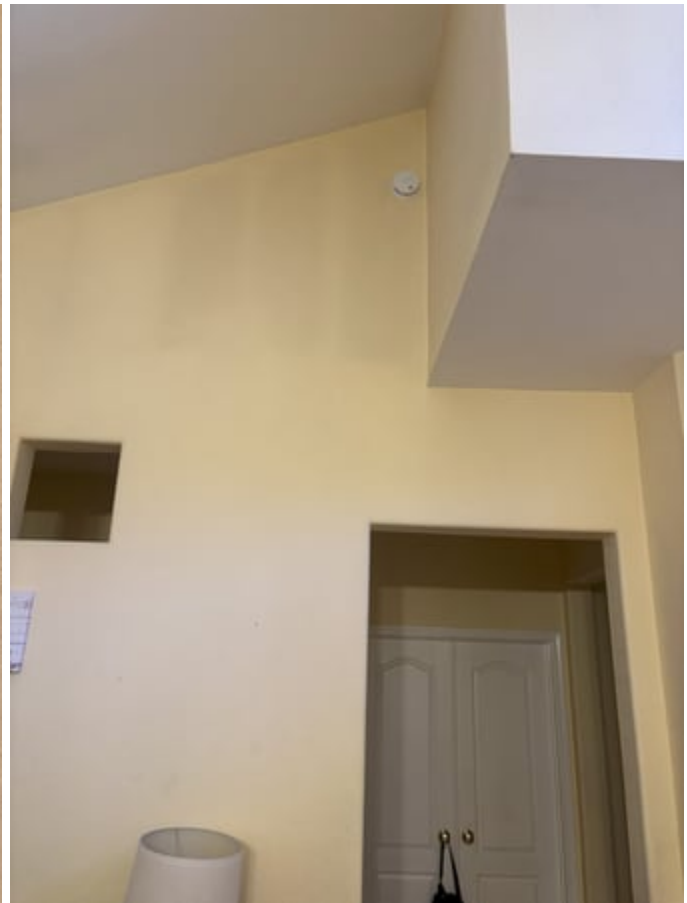
There were smoke detectors present in each of the bedrooms, kitchen, adjacent to the fireplace, kitchen, and the hallway.
