Mock Inspection Report

5037 Chicago Avenue, Fair Oaks, CA, USA

Jul 2, 2025

Performed by **David Erler**

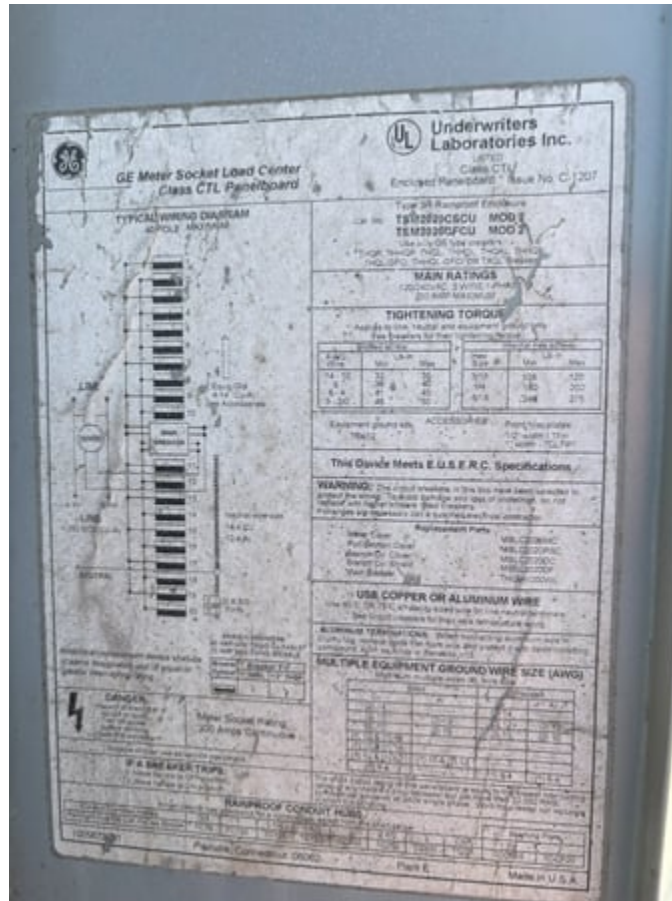
- The main service disconnect was labeled for 200 amps.

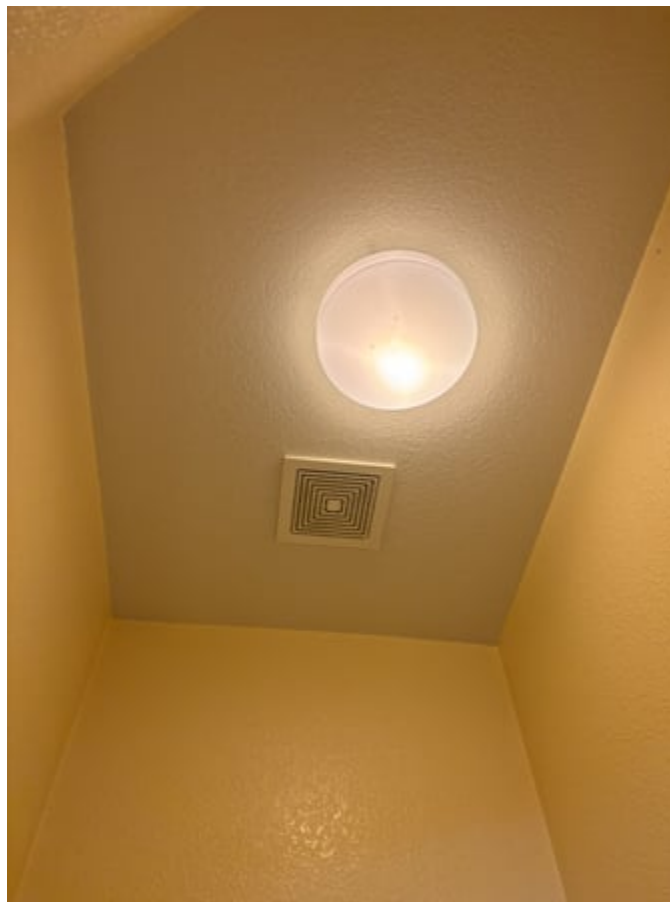
The kitchen, all three bathrooms, and the laundry room had working exhaust systems in them.

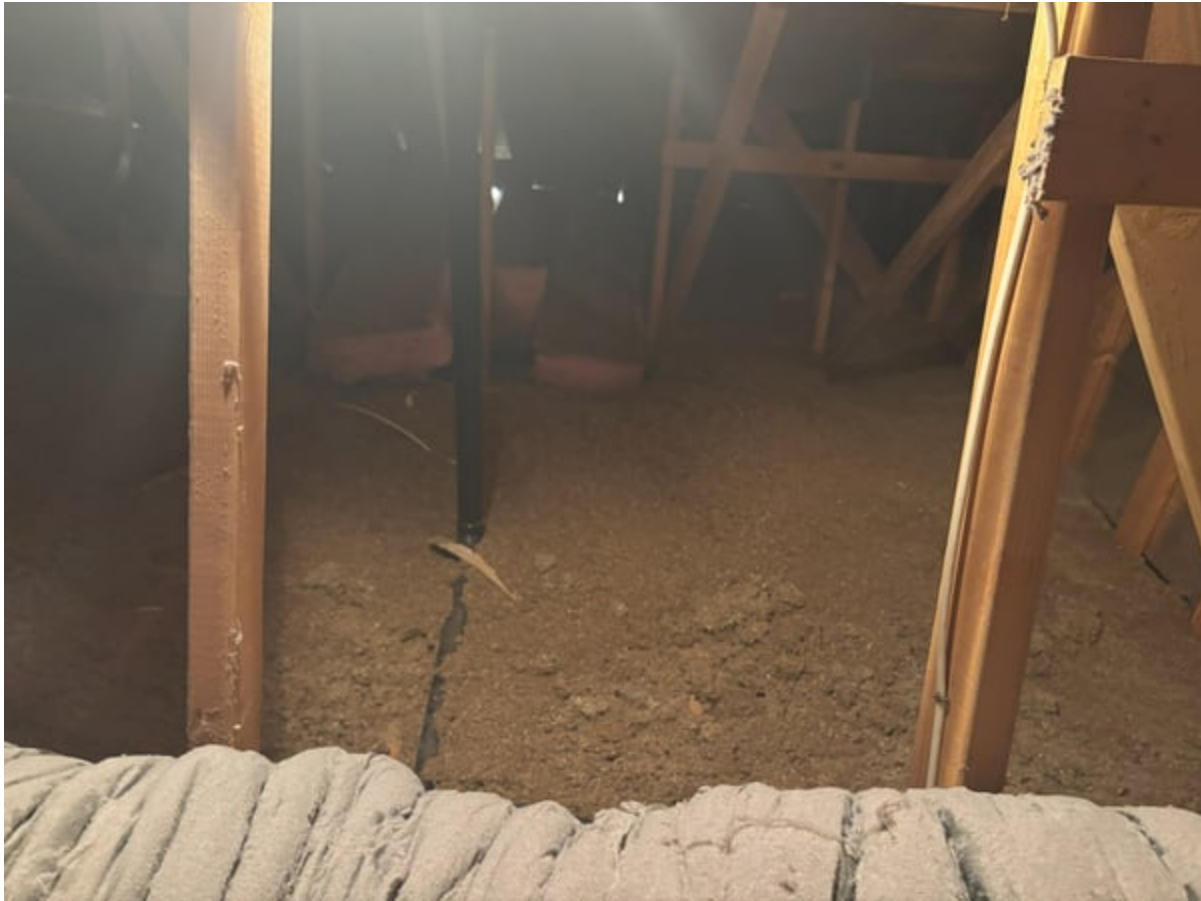
- The attic had blown-in cellulose insulation.

- The insulation thickness was approximately twelve inches thick.

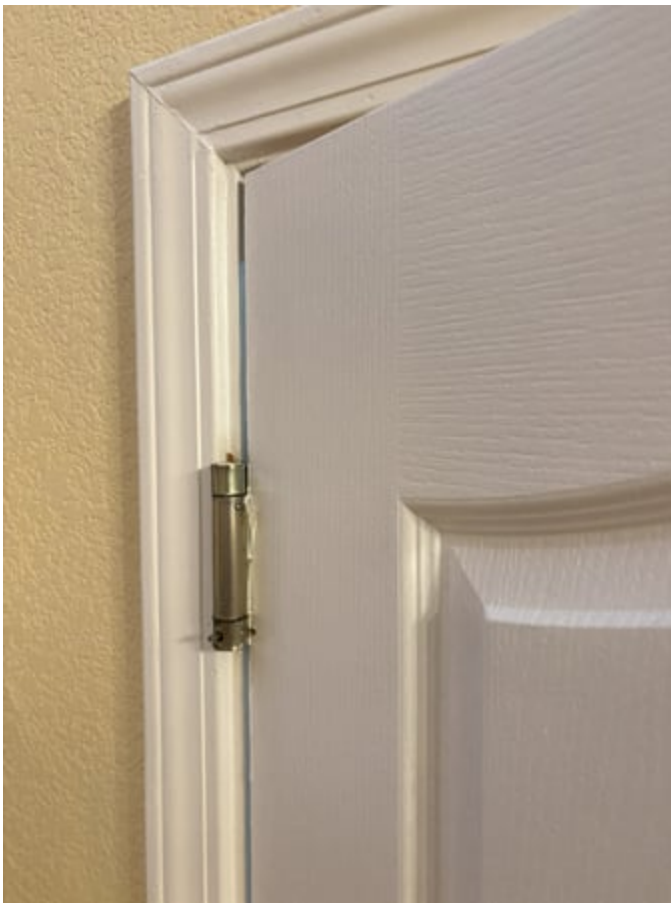
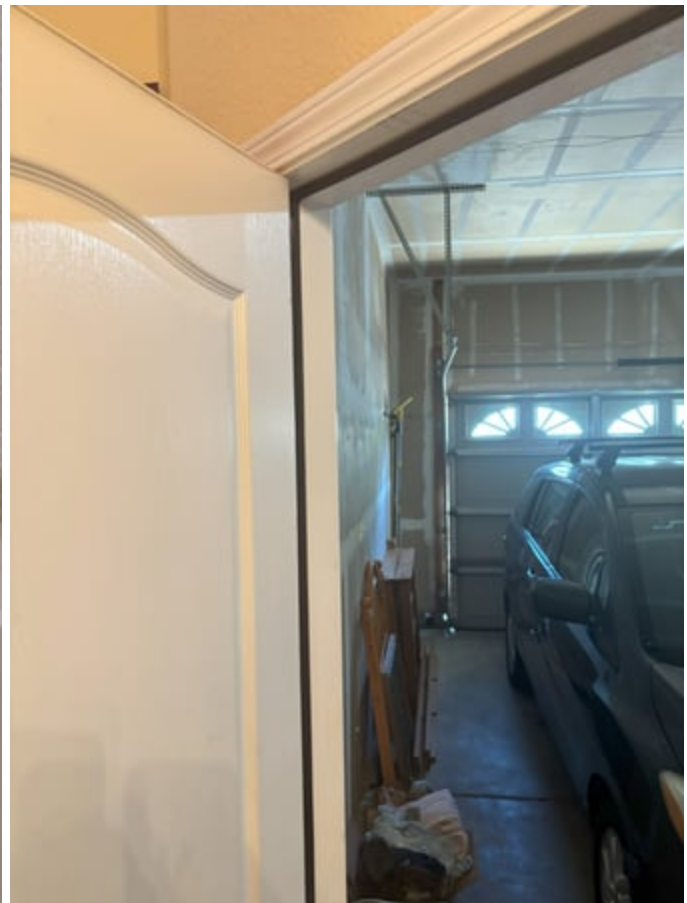
No defects observed on any of the interior doors. The interior garage door had a self-latching hinge system installed on it that functioned properly.
